**King County**  
**ADA Self-Evaluation and Transition Plan Update**  
**Facility Cost Projection Summary**  
**August 2023**

# Site Accessibility Evaluation

**Burien PnR Garage (KC)**  
**14900 4th Ave SW**  
**Burien, WA 98166**  
**Accessibility Evaluation**  
**Inspection Date: 07/11/2023**  
**Evaluators: Kalia Klein**

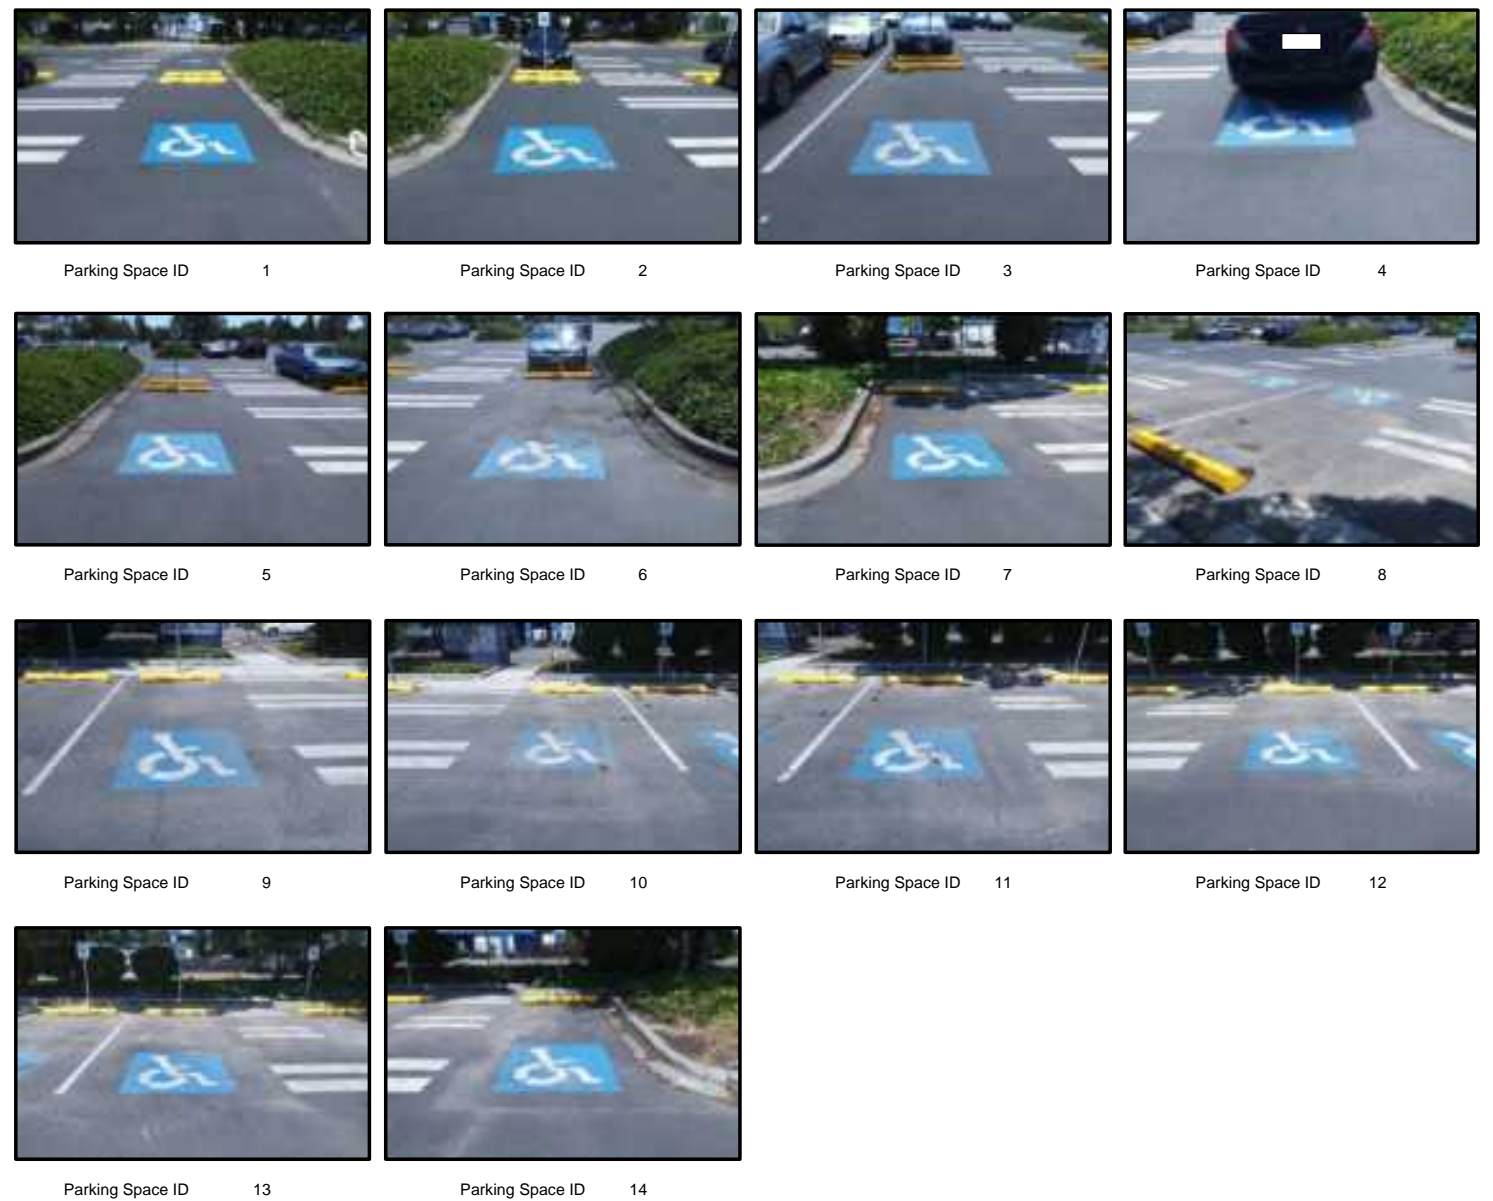
Parking Space Issue	Parking Space ID														Possible Solutions
	P1	P2	P3	P4	P5	P6	P7	P8	P9	P10	P11	P12	P13	P14	
Parking space not marked as accessible							X								Remove and replace pavement markings
Parking space width is less than 96"															
Parking space does not have an adjacent access aisle															
Car parking space access aisle width is less than 60"															
Van parking space access aisle width is less than 96"													X		
Access aisle does not extend the full length of the parking space it serves															
Access aisle is not marked to discourage parking in the aisle															
Access aisle overlaps the vehicular way															
Access aisle does not adjoin an accessible route															
Constrained width where the access aisle adjoins the accessible route is less than 48"															
Access aisle has change in level > 0.25"					X		X		X						Repave and restripe access aisle or relocate access aisle

Access aisle has horizontal openings > 0.5"							X								
Access aisle running slope is > 2%					X		X								
Access aisle cross slope is > 2%	X	X	X		X										
Parking space has change in level > 0.25"													X		
Parking space horizontal openings > 0.5"												X			
Parking space running slope is > 2%													X	X	
Parking space cross slope is > 2%	X		X	X	X		X								
Parking space vertical clearance is < 98"															
Parking space identification sign is missing or incorrect

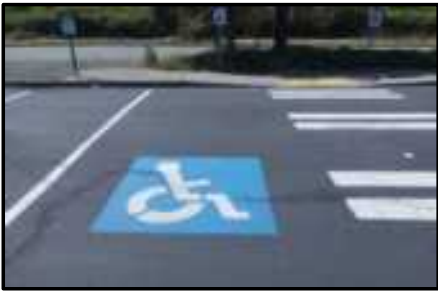
Parking Space ID 15

Parking Space Issue	P15 P16 P17 P18				Parking Space ID	Possible Solutions
Parking space not marked as accessible						
Parking space width is less than 96"						
Parking space does not have an adjacent access aisle						
Car parking space access aisle width is less than 60"						
Van parking space access aisle width is less than 96"						
Access aisle does not extend the full length of the parking space it serves						
Access aisle is not marked to discourage parking in the aisle			X			Install access aisle hatch pavement markings
Access aisle overlaps the vehicular way						
Access aisle does not adjoin an accessible route						
Constrained width where the access aisle adjoins the accessible route is less than 48"						
Access aisle has change in level > 0.25"	X		X			
Access aisle has horizontal openings > 0.5"			X			Repave and restripe access aisle or relocate access aisle
Access aisle running slope is > 2%

Access aisle cross slope is > 2%						
Parking space has change in level > 0.25"		X		X		
Parking space horizontal openings > 0.5"						
Parking space running slope is > 2%						Repave and restripe accessible parking space or relocate accessible parking space
Parking space cross slope is > 2%		X				
Parking space vertical clearance is < 98"						
Parking space identification sign is missing or incorrect				X		Install accessible parking sign

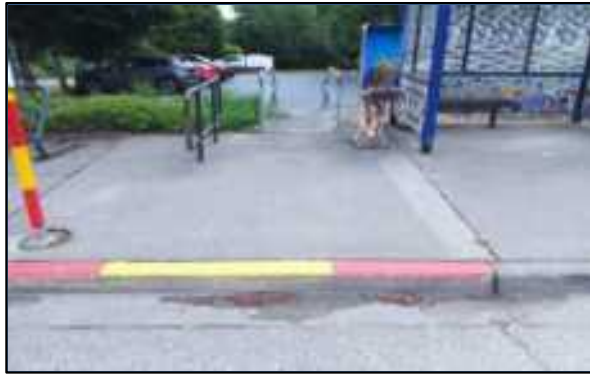
Boarding/Alighting Area

Boarding Area Issues	Issue Exists	Possible Solutions
Boarding area does not exist		
Boarding area length is less than 96"		
Boarding area width is less than 60"		
Boarding area running slope is greater than 2%		
Boarding area cross slope is greater than adjacent street grade		
Heaving/Sinking/Cracking present in the boarding area		
Ponding present in the boarding area		
Permanent obstruction (>0.25") in boarding area		
Temporary obstruction (>0.25") in boarding area		
Transition at connection to the curb is greater than 0.25"		
Boarding area is missing a connection to the street or sidewalk network		
Adjacent Sidewalk Network Issues	Issue Exists	Possible Solutions
Sidewalk network width is less than 48"		
Sidewalk network cross slope is greater than 2%		
Heaving/Sinking/Cracking present in the sidewalk network		
Ponding present in the sidewalk network		
Permanent obstruction (>0.25") in sidewalk network

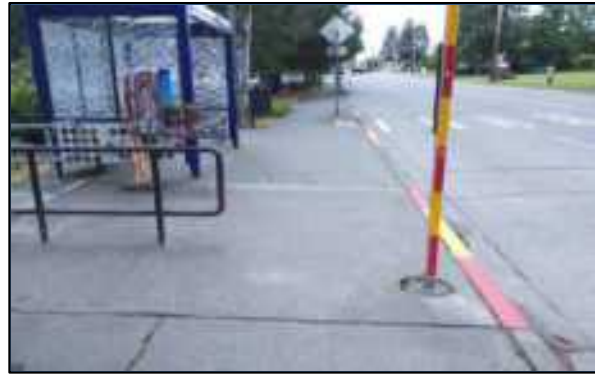
Adjacent Sidewalk Network

Temporary obstruction (>0.25") in sidewalk network		
Transition at connection to boarding area is greater than 0.25"		
Transit Stop Sidewalk Issues	Issue Exists	Possible Solutions
Transit stop sidewalk cross slope is greater than 2%		
Heaving/Sinking/Cracking present in the transit stop sidewalk		
Ponding present in the transit stop sidewalk		
Permanent obstruction (>0.25") in transit stop sidewalk		
Temporary obstruction (>0.25") in transit stop sidewalk		
Transition at connection to sidewalk network is greater than 0.25"		
Transit Stop Amenity Issues	Issue Exists	Possible Solutions
No transit stop signage		
Transit stop signage is non-compliant	X	Remove and replace transit stop signage
No clear space adjacent to stand-alone bench		
Stand-alone bench clear space length is less than 48"		
Stand-alone bench clear space width is less than 30"		
Stand-alone bench clear space running slope is greater than 2%

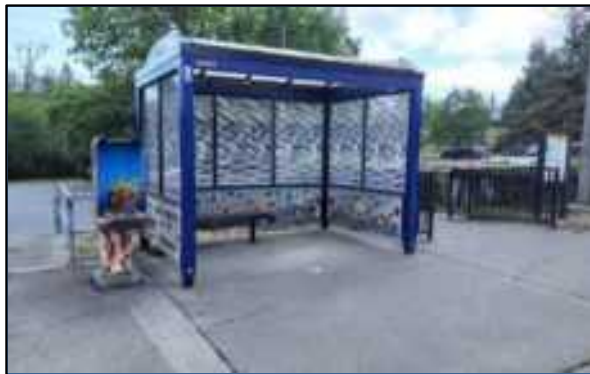
Shelter/Clear Space

No clear space under shelter		
Shelter clear space length is less than 48"		
Shelter clear space width is less than 30"		
Shelter clear space running slope is greater than 2%		
Shelter opening clear width is less than 32"

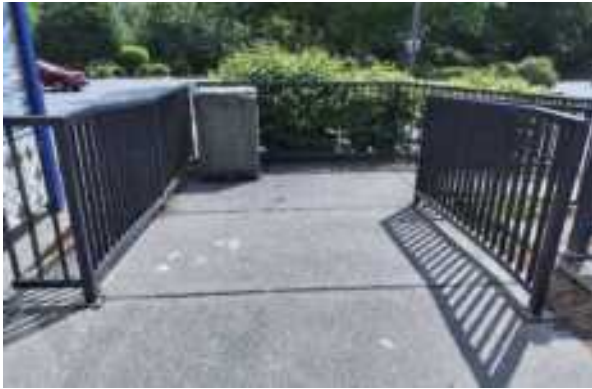
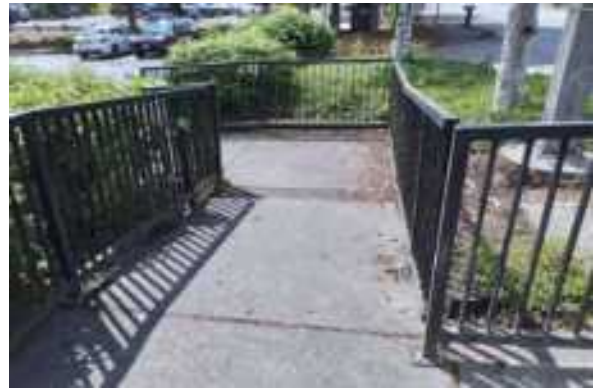
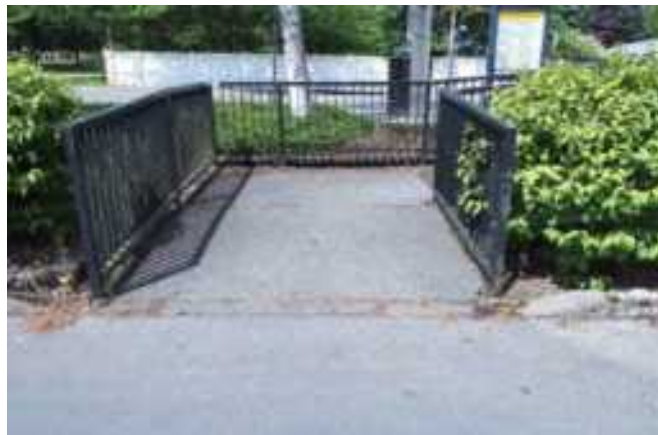
Ramp Issues	Ramp ID	Possible Solutions
Running slope of the ramp is greater than 8.3%	X	
Cross slope of the ramp is greater than 2.0%		
Clear width of the ramp between handrails is less than 36 inches		Remove and replace ramp
The rise of the ramp run is greater than 30 inches		
Permanent obstruction (>0.25") on ramp or landings	X	
Ponding occurs on the ramp or landings	X	Fix ponding
The landing space at the bottom of the ramp does not exist and is needed		
The landing space at the bottom of the ramp is less than 60 inches by 36 inches		
The landing space at the bottom of the ramp has a run slope greater than 2.0%	X	Remove and replace bottom landing
The landing space at the bottom of the ramp has a cross slope greater than 2.0%		
The landing space at the top of the ramp does not exist and is needed		
The landing space at the top of the ramp is less than 60 inches by 36 inches		
The landing space at the top of the ramp has a run slope greater than 2.0%		Remove and replace top landing

Handrail Issues		Possible Solutions
Handrails are not provided where the running slope is greater than 5% and rise is greater than 6 inches		
The surface of the ramp does not extend at least 1' foot beyond the inside face of the handrail OR a barrier is not provided that prevents the passage of a 4 inch diameter sphere, where any portion of the sphere is within 4 inches of the finish surface	X	
Handrail is not provided on both sides of the ramp		
Handrail is not provided along the full length of the ramp		
The top of the gripping surface of handrail is less than 34 inches or greater than 38 inches above walking surface	X	
Clearance between handrail gripping surface and adjacent surface is less than 1.5 inches		
Handrail gripping surface is not continuous along length		Remove and replace handrail
Handrail gripping surface is obstructed along top, side, or greater than 20% of bottom		
Where provided, horizontal projection is less than 1.5 inches below the bottom of the handrail gripping surface

Handrail gripping surfaces with a circular cross section have an outside diameter less than 1.25 inches or greater than 2 inches		
Handrail gripping surfaces with a non-circular cross section have perimeter dimension of less than 4 inches or greater than 6.25 inches or cross-section dimension greater than 2.25 inches	X	
Handrail gripping surface or adjacent surface has sharp or abrasive elements or non-rounded edges		
Handrail rotates within their fittings		
Handrails extend less than 12 inches in the direction of travel at the bottom and top of the ramp	X

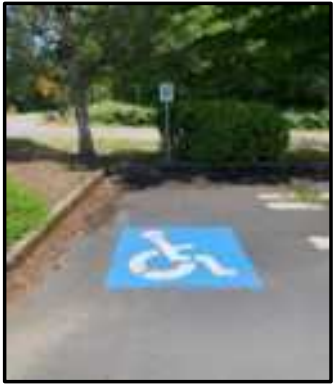
Parking Space ID 1

Parking Space Issue	P1	P2	Parking Space ID	Possible Solutions
Parking space not marked as accessible				
Parking space width is less than 96"				
Parking space does not have an adjacent access aisle				
Car parking space access aisle width is less than 60"				
Van parking space access aisle width is less than 96"	x			Remove and replace pavement markings
Access aisle does not extend the full length of the parking space it serves				Install access aisle hatch pavement markings
Access aisle is not marked to discourage parking in the aisle	x			
Access aisle overlaps the vehicular way				
Access aisle does not adjoin an accessible route				
Constrained width where the access aisle adjoins the accessible route is less than 48"				
Access aisle has change in level > 0.25"	x			
Access aisle has horizontal openings > 0.5"	x			Repave and restripe access aisle or relocate access aisle
Access aisle running slope is > 2%	x

Access aisle cross slope is > 2%	x			
Parking space has change in level > 0.25"	x	x		
Parking space horizontal openings > 0.5"		x		
Parking space running slope is > 2%	x	x		Repave and restripe accessible parking space or relocate accessible parking space
Parking space cross slope is > 2%	x	x		
Parking space vertical clearance is < 98"				
Parking space identification sign is missing or incorrect

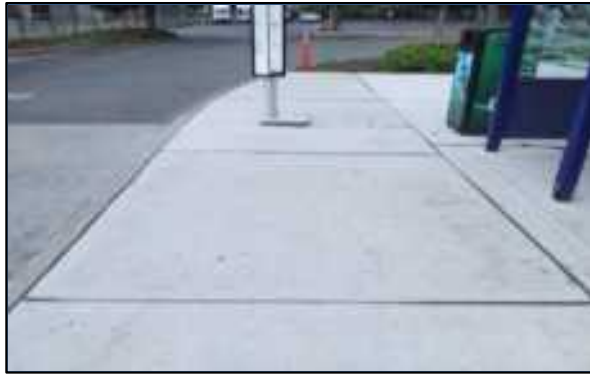
Boarding/Alighting Area

Boarding Area Issues	Issue Exists	Possible Solutions
Boarding area does not exist		
Boarding area length is less than 96"		
Boarding area width is less than 60"		
Boarding area running slope is greater than 2%		
Boarding area cross slope is greater than adjacent street grade		
Heaving/Sinking/Cracking present in the boarding area		
Ponding present in the boarding area		
Permanent obstruction (>0.25") in boarding area		
Temporary obstruction (>0.25") in boarding area		
Transition at connection to the curb is greater than 0.25"		
Boarding area is missing a connection to the street or sidewalk network		
Adjacent Sidewalk Network Issues	Issue Exists	Possible Solutions
Sidewalk network width is less than 48"		
Sidewalk network cross slope is greater than 2%		
Heaving/Sinking/Cracking present in the sidewalk network		
Ponding present in the sidewalk network		
Permanent obstruction (>0.25") in sidewalk network

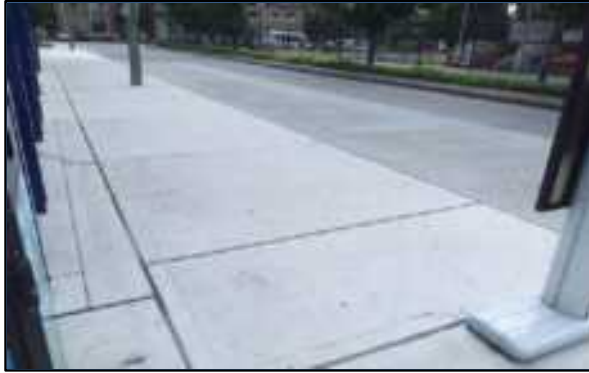
Boarding/Alighting Area

Boarding Area Issues	Issue Exists	Possible Solutions
Boarding area does not exist		
Boarding area length is less than 96"		
Boarding area width is less than 60"		
Boarding area running slope is greater than 2%		
Boarding area cross slope is greater than adjacent street grade		
Heaving/Sinking/Cracking present in the boarding area		
Ponding present in the boarding area		
Permanent obstruction (>0.25") in boarding area		
Temporary obstruction (>0.25") in boarding area		
Transition at connection to the curb is greater than 0.25"		
Boarding area is missing a connection to the street or sidewalk network		
Adjacent Sidewalk Network Issues	Issue Exists	Possible Solutions
Sidewalk network width is less than 48"		
Sidewalk network cross slope is greater than 2%		
Heaving/Sinking/Cracking present in the sidewalk network		
Ponding present in the sidewalk network		
Permanent obstruction (>0.25") in sidewalk network

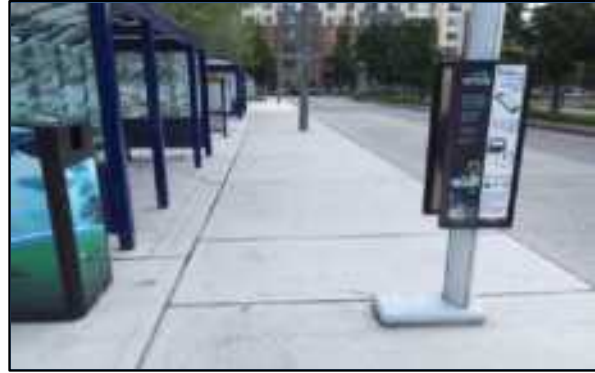
Adjacent Sidewalk Network

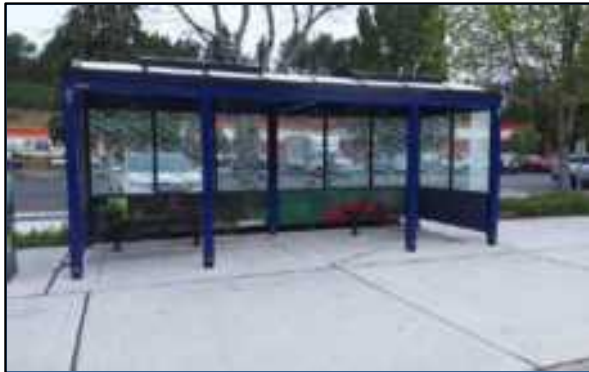
Shelter/Clear Space

No clear space under shelter		
Shelter clear space length is less than 48"		
Shelter clear space width is less than 30"		
Shelter clear space running slope is greater than 2%		
Shelter opening clear width is less than 32"

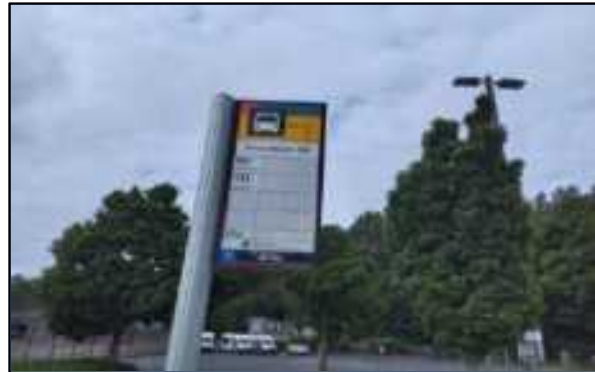
Transit Stop Signage

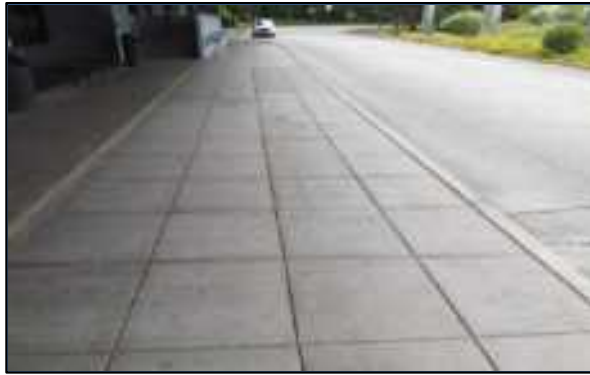
Boarding/Alighting Area

Boarding Area Issues	Issue Exists	Possible Solutions
Boarding area does not exist		
Boarding area length is less than 96"		
Boarding area width is less than 60"		
Boarding area running slope is greater than 2%	X	Remove and replace boarding area
Boarding area cross slope is greater than adjacent street grade		
Heaving/Sinking/Cracking present in the boarding area		
Ponding present in the boarding area		
Permanent obstruction (>0.25") in boarding area		
Temporary obstruction (>0.25") in boarding area		
Transition at connection to the curb is greater than 0.25"		
Boarding area is missing a connection to the street or sidewalk network		
Adjacent Sidewalk Network Issues	Issue Exists	Possible Solutions
Sidewalk network width is less than 48"		
Sidewalk network cross slope is greater than 2%		
Heaving/Sinking/Cracking present in the sidewalk network		
Ponding present in the sidewalk network		
Permanent obstruction (>0.25") in sidewalk network

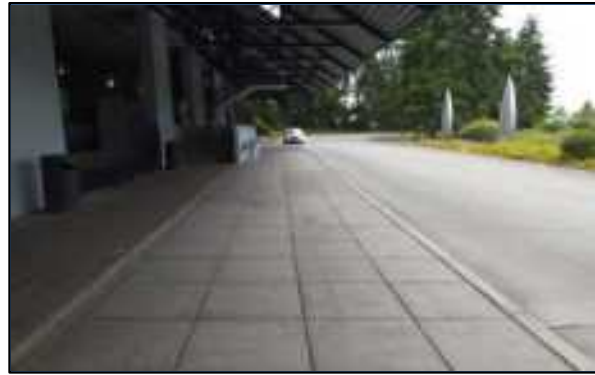
Adjacent Sidewalk Network

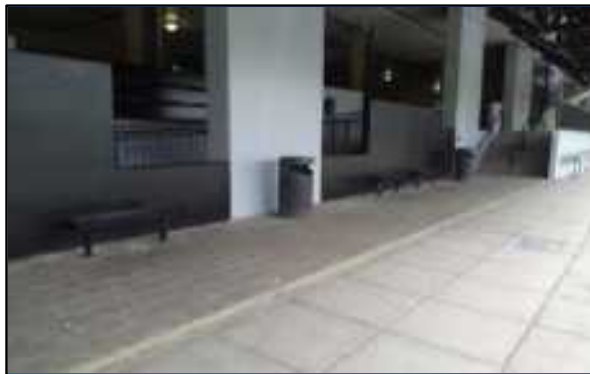
Shelter/Clear Space

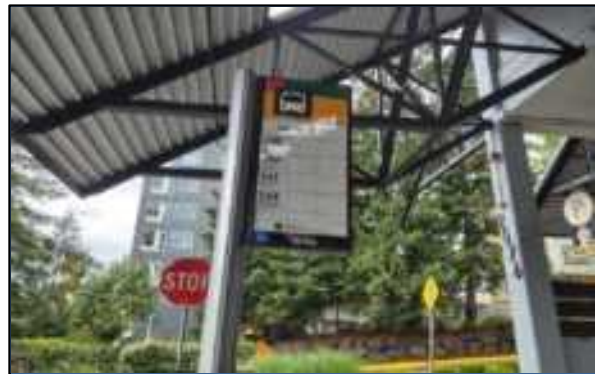
Transit Stop Signage

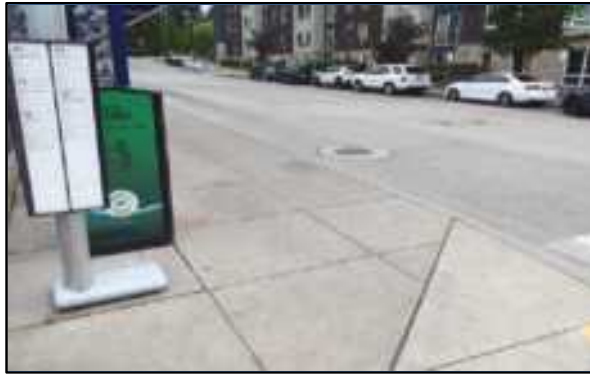
Boarding/Alighting Area

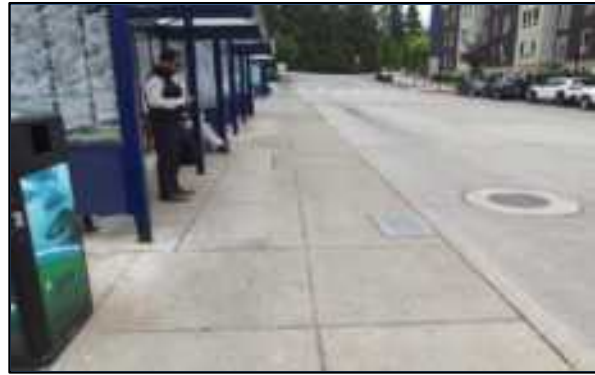
Adjacent Sidewalk Network

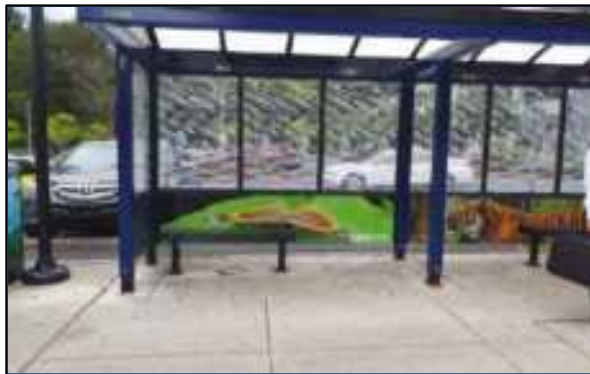
Shelter/Clear Space

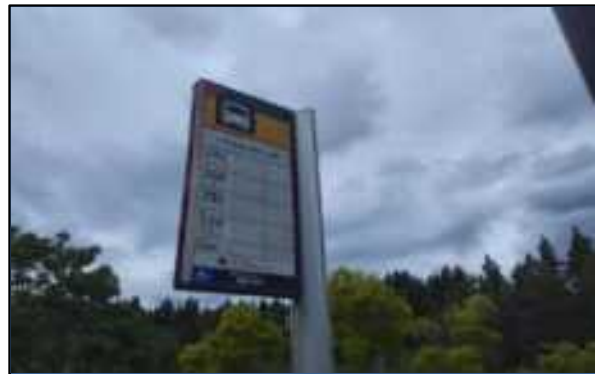
Transit Stop Signage

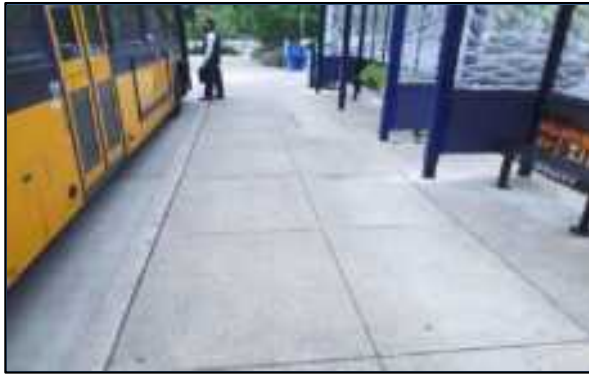
Boarding/Alighting Area

Boarding Area Issues	Issue Exists	Possible Solutions
Boarding area does not exist		
Boarding area length is less than 96"		
Boarding area width is less than 60"		
Boarding area running slope is greater than 2%	X	Remove and replace boarding area
Boarding area cross slope is greater than adjacent street grade		
Heaving/Sinking/Cracking present in the boarding area		
Ponding present in the boarding area		
Permanent obstruction (>0.25") in boarding area		
Temporary obstruction (>0.25") in boarding area		
Transition at connection to the curb is greater than 0.25"		
Boarding area is missing a connection to the street or sidewalk network		
Adjacent Sidewalk Network Issues	Issue Exists	Possible Solutions
Sidewalk network width is less than 48"		
Sidewalk network cross slope is greater than 2%		
Heaving/Sinking/Cracking present in the sidewalk network		
Ponding present in the sidewalk network		
Permanent obstruction (>0.25") in sidewalk network

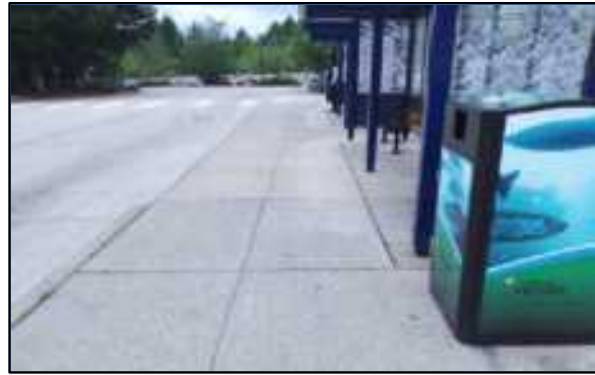
Adjacent Sidewalk Network

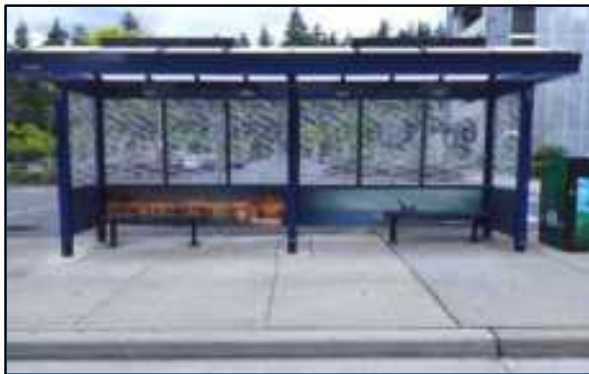
Shelter/Clear Space

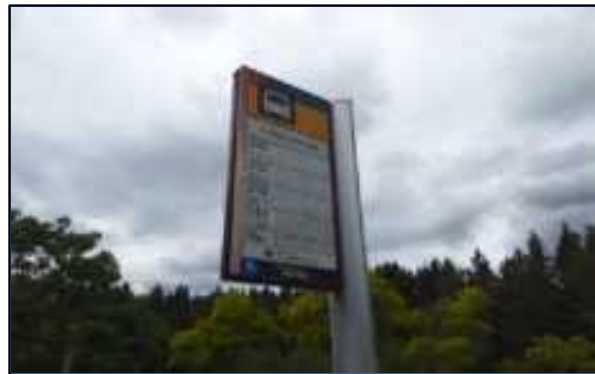
Transit Stop Signage

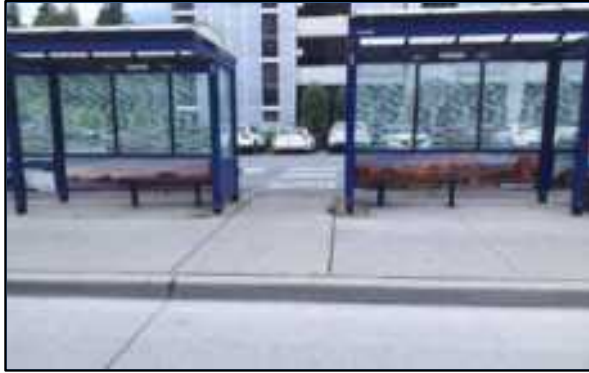
Boarding/Alighting Area

Boarding Area Issues	Issue Exists	Possible Solutions
Boarding area does not exist		
Boarding area length is less than 96"		
Boarding area width is less than 60"		
Boarding area running slope is greater than 2%	X	Remove and replace boarding area
Boarding area cross slope is greater than adjacent street grade		
Heaving/Sinking/Cracking present in the boarding area		
Ponding present in the boarding area		
Permanent obstruction (>0.25") in boarding area		
Temporary obstruction (>0.25") in boarding area		
Transition at connection to the curb is greater than 0.25"		
Boarding area is missing a connection to the street or sidewalk network		
Adjacent Sidewalk Network Issues	Issue Exists	Possible Solutions
Sidewalk network width is less than 48"		
Sidewalk network cross slope is greater than 2%		
Heaving/Sinking/Cracking present in the sidewalk network		
Ponding present in the sidewalk network		
Permanent obstruction (>0.25") in sidewalk network

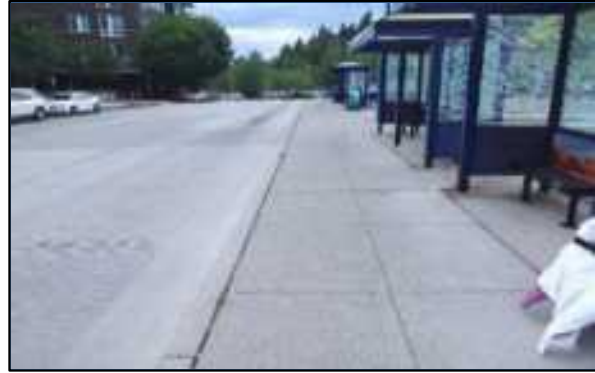
Adjacent Sidewalk Network

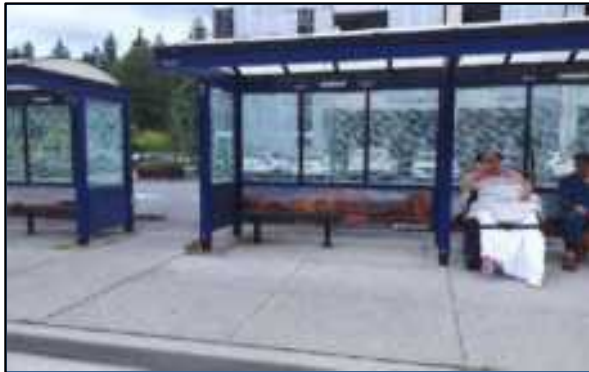
Shelter/Clear Space

No clear space under shelter		
Shelter clear space length is less than 48"		
Shelter clear space width is less than 30"		
Shelter clear space running slope is greater than 2%	X	Remove and replace clear space
Shelter opening clear width is less than 32"

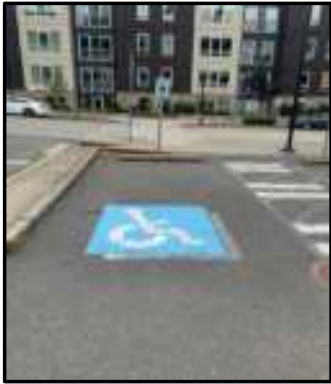
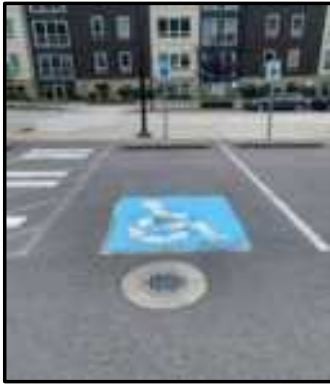
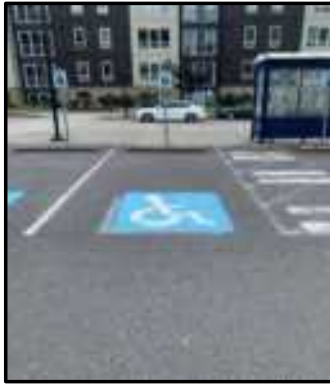
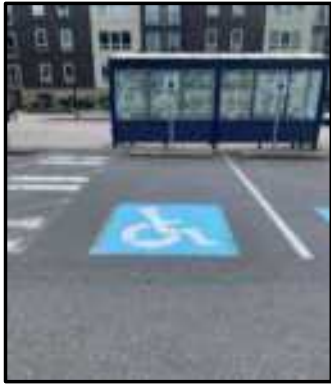
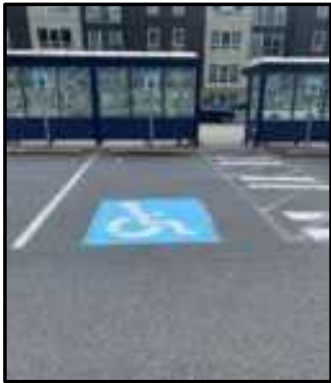
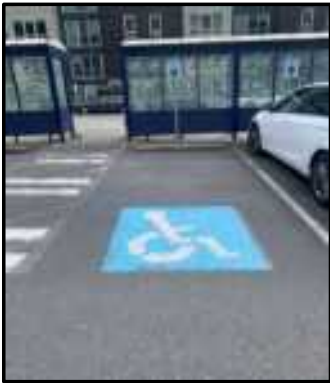
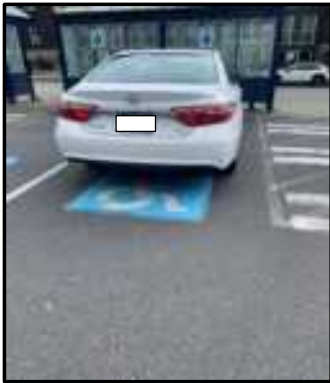
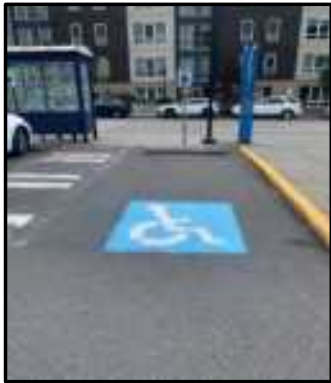
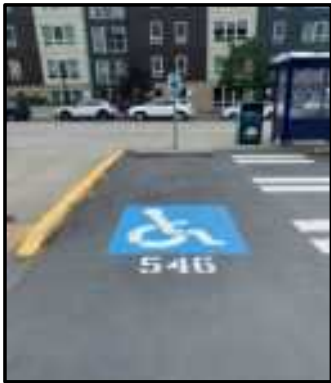
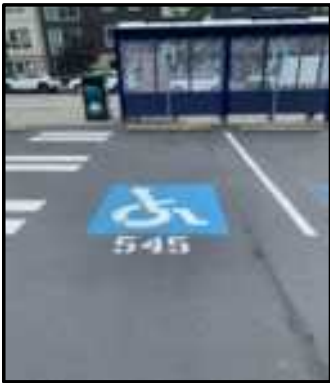
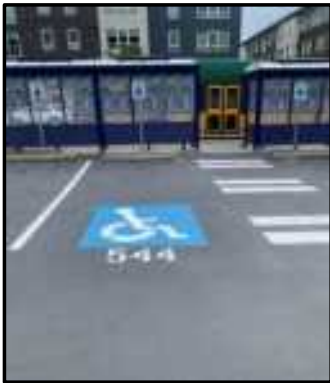
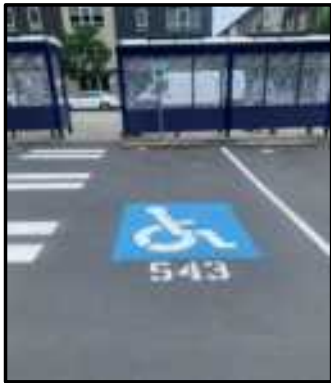
Parking Space Issue	Parking Space ID												Possible Solutions
	P1	P2	P3	P4	P5	P6	P7	P8	P9	P10	P11	P12	
Parking space not marked as accessible		x	x	x			x						Install access aisle hatch pavement markings
Parking space width is less than 96"													
Parking space does not have an adjacent access aisle													
Car parking space access aisle width is less than 60"													
Van parking space access aisle width is less than 96"													
Access aisle does not extend the full length of the parking space it serves													
Access aisle is not marked to discourage parking in the aisle	x		x		x		x						
Access aisle overlaps the vehicular way													
Access aisle does not adjoin an accessible route													
Constrained width where the access aisle adjoins the accessible route is less than 48"													
Access aisle has change in level > 0.25"													Repave and restripe access aisle or relocate access aisle

Access aisle has horizontal openings > 0.5"													
Access aisle running slope is > 2%			x										
Access aisle cross slope is > 2%	x		x		x		x				x		
Parking space has change in level > 0.25"													Repave and restripe accessible parking space or relocate accessible parking space
Parking space horizontal openings > 0.5"		x											
Parking space running slope is > 2%	x	x							x	x		x	
Parking space cross slope is > 2%			x			x	x	x	x	x	x	x	
Parking space vertical clearance is < 98"													Install accessible parking sign
Parking space identification sign is missing or incorrect							x

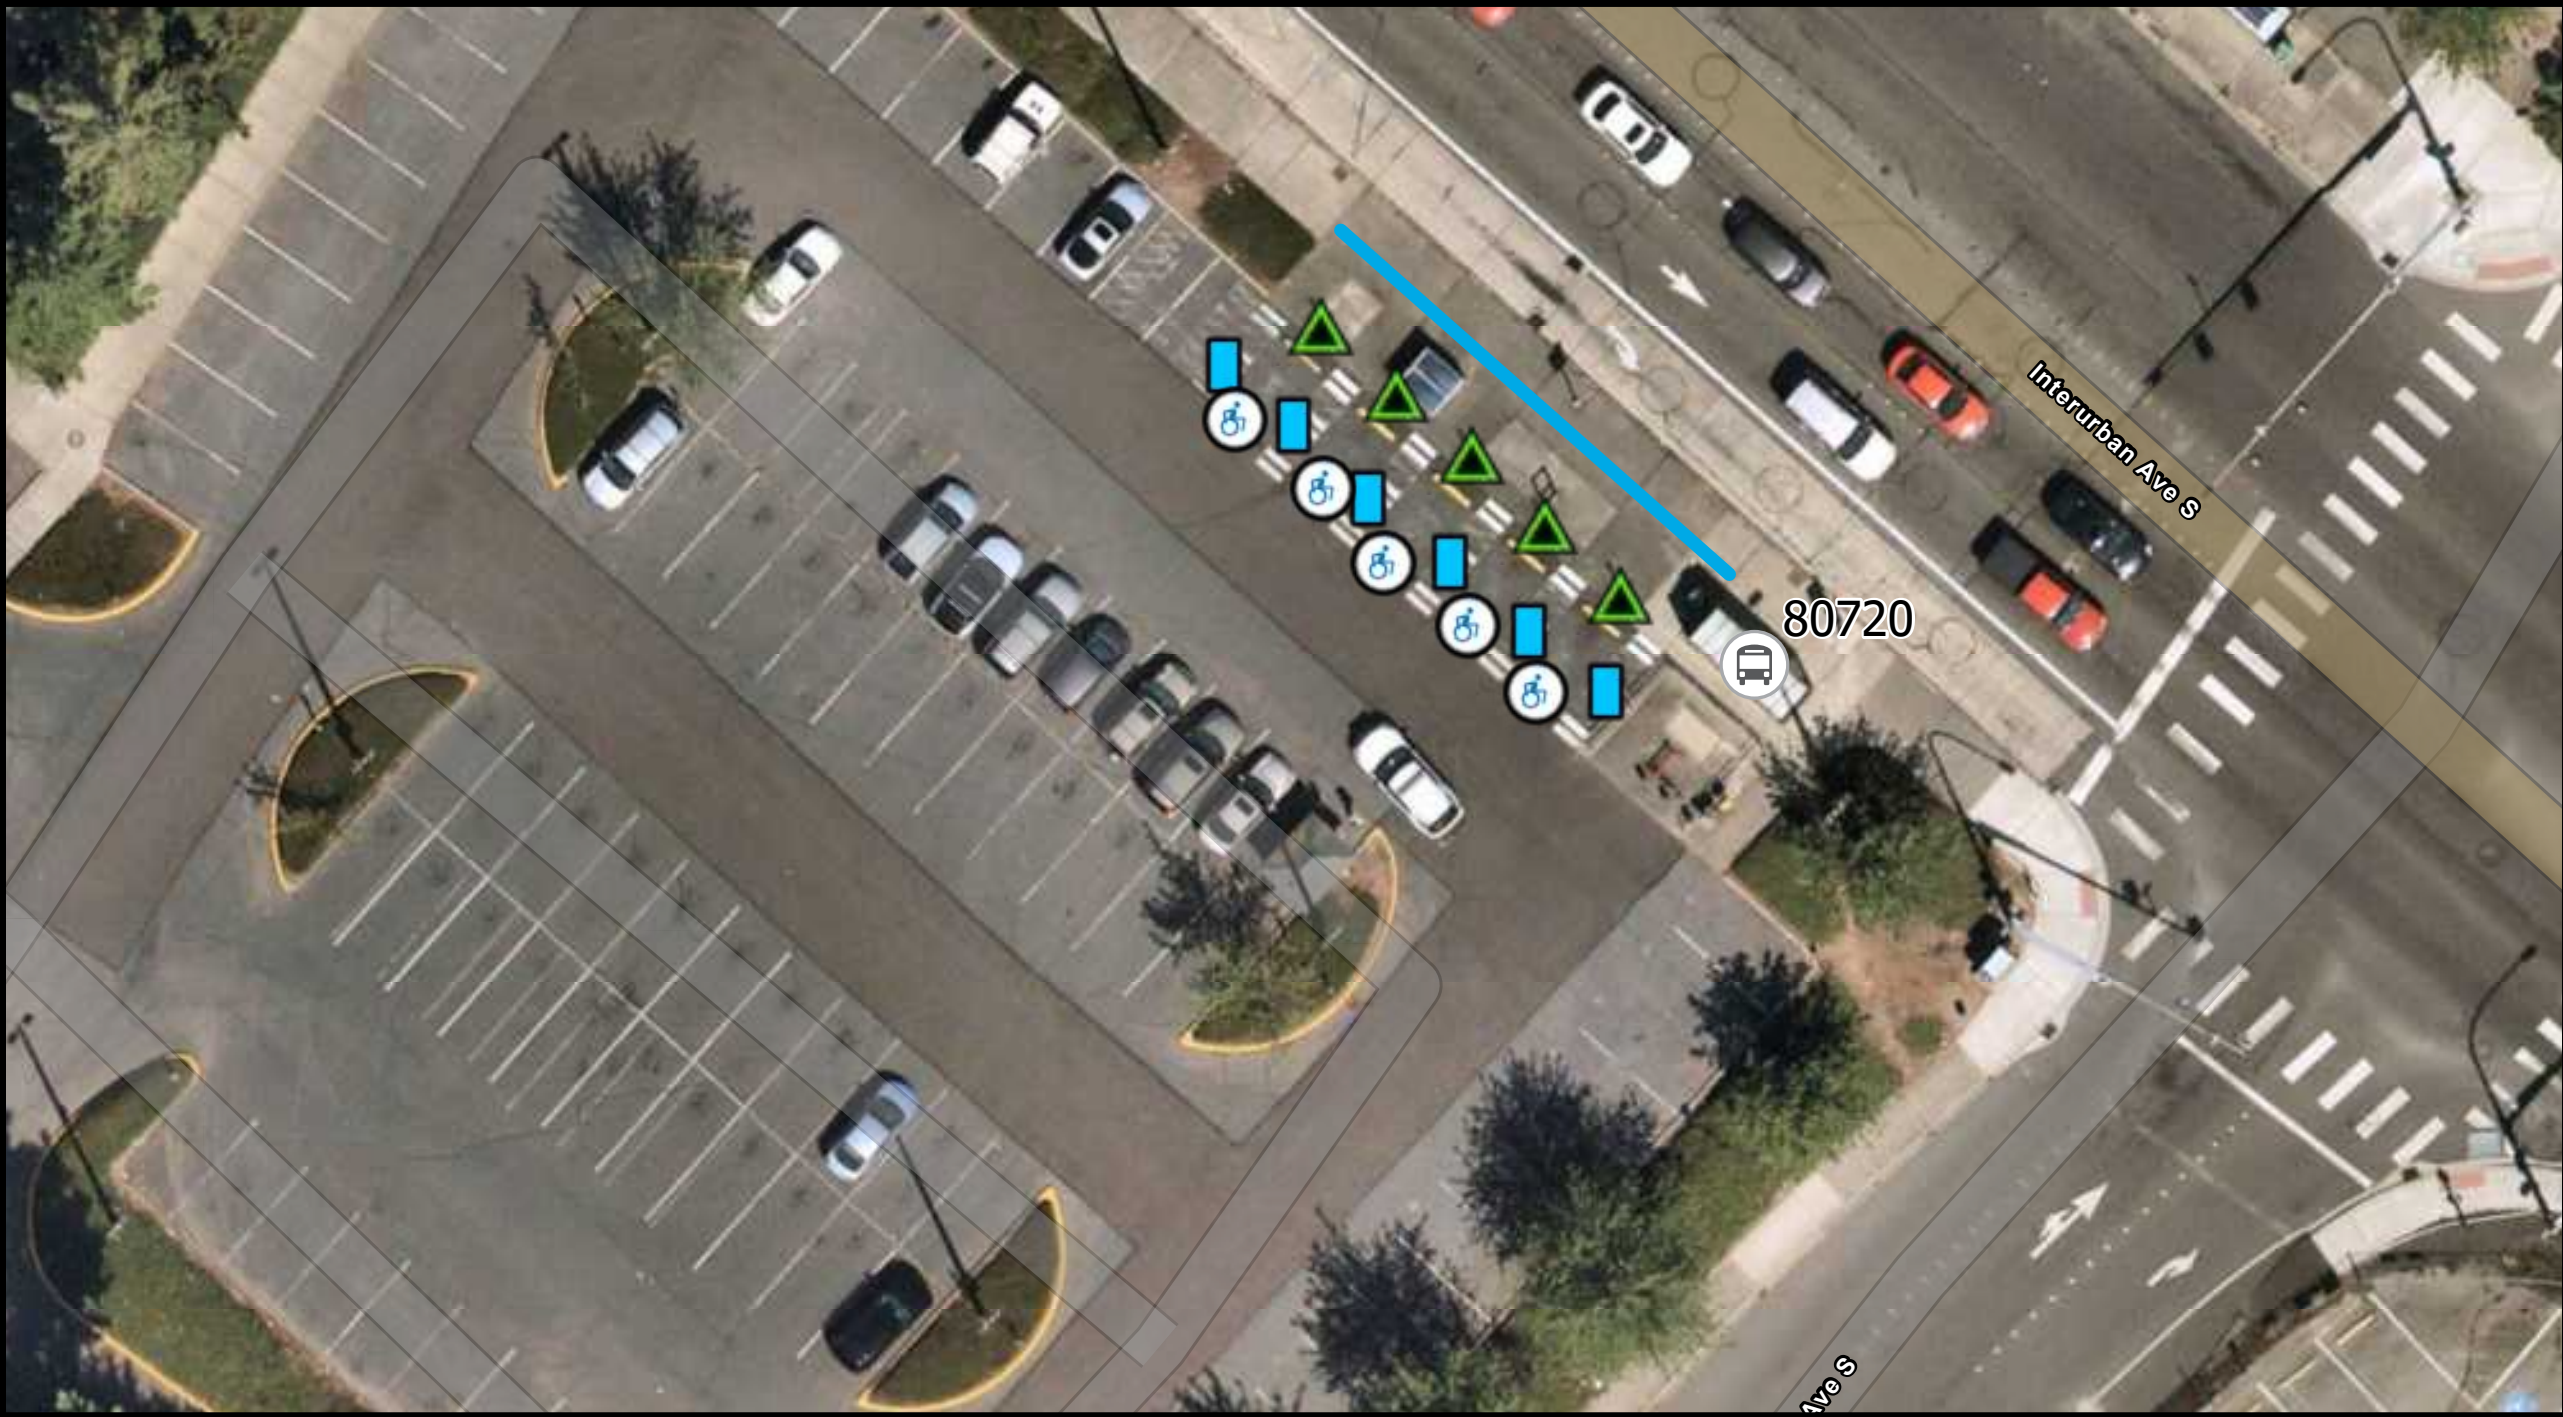
Facility Quantity Summary of Evaluated Elements	
	Feet
Path of Travel	68
	Quantity
Intersections with Curb Ramps	0
Ramps	0
Transit Stops	1
Accessible Parking Spaces	5

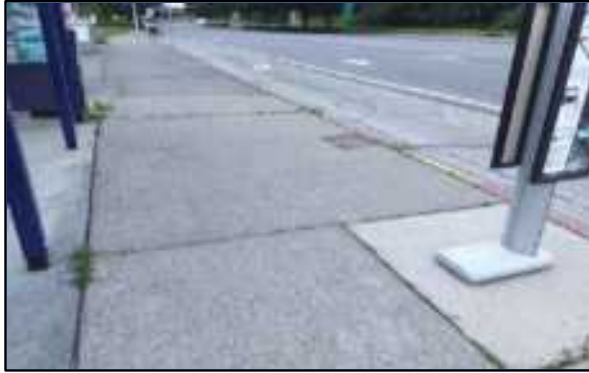
Boarding/Alighting Area

Boarding Area Issues	Issue Exists	Possible Solutions
Boarding area does not exist		
Boarding area length is less than 96"		
Boarding area width is less than 60"		
Boarding area running slope is greater than 2%		
Boarding area cross slope is greater than adjacent street grade		
Heaving/Sinking/Cracking present in the boarding area		
Ponding present in the boarding area		
Permanent obstruction (>0.25") in boarding area		
Temporary obstruction (>0.25") in boarding area		
Transition at connection to the curb is greater than 0.25"	X	Fix connection transition
Boarding area is missing a connection to the street or sidewalk network		
Adjacent Sidewalk Network Issues	Issue Exists	Possible Solutions
Sidewalk network width is less than 48"		
Sidewalk network cross slope is greater than 2%		
Heaving/Sinking/Cracking present in the sidewalk network		
Ponding present in the sidewalk network		
Permanent obstruction (>0.25") in sidewalk network

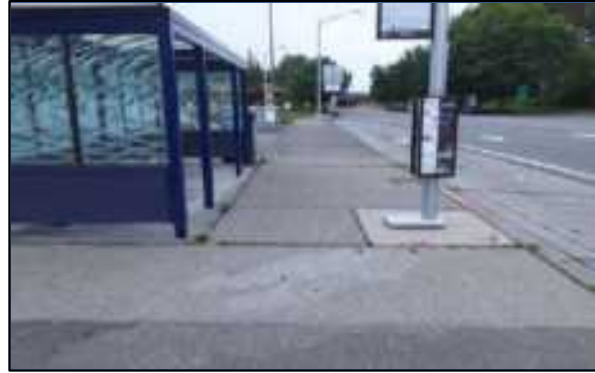
Adjacent Sidewalk Network

Temporary obstruction (>0.25") in sidewalk network		
Transition at connection to boarding area is greater than 0.25"		
Transit Stop Sidewalk Issues	Issue Exists	Possible Solutions
Transit stop sidewalk cross slope is greater than 2%		
Heaving/Sinking/Cracking present in the transit stop sidewalk		
Ponding present in the transit stop sidewalk		
Permanent obstruction (>0.25") in transit stop sidewalk		
Temporary obstruction (>0.25") in transit stop sidewalk		
Transition at connection to sidewalk network is greater than 0.25"		
Transit Stop Amenity Issues	Issue Exists	Possible Solutions
No transit stop signage		
Transit stop signage is non-compliant	X	Remove and replace transit stop signage
No clear space adjacent to stand-alone bench		
Stand-alone bench clear space length is less than 48"		
Stand-alone bench clear space width is less than 30"		
Stand-alone bench clear space running slope is greater than 2%

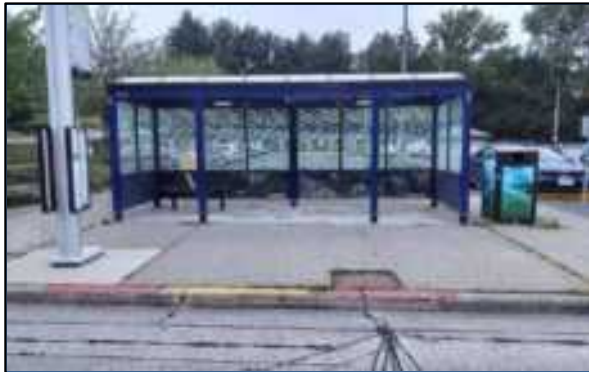
Shelter/Clear Space

No clear space under shelter		
Shelter clear space length is less than 48"		
Shelter clear space width is less than 30"		
Shelter clear space running slope is greater than 2%		
Shelter opening clear width is less than 32"

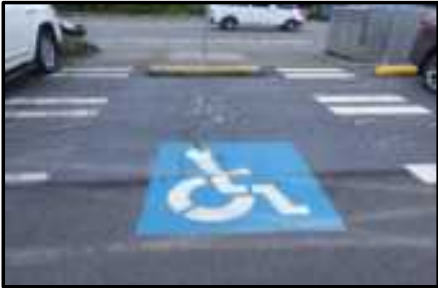
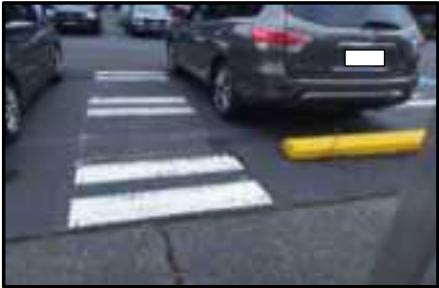
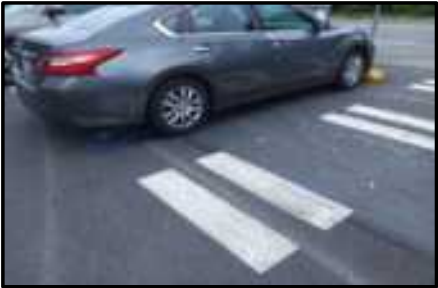
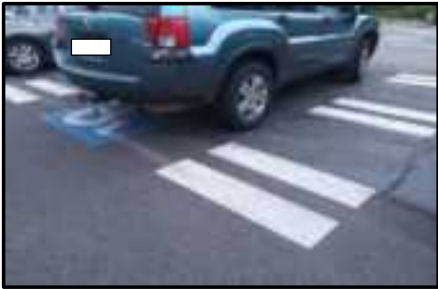
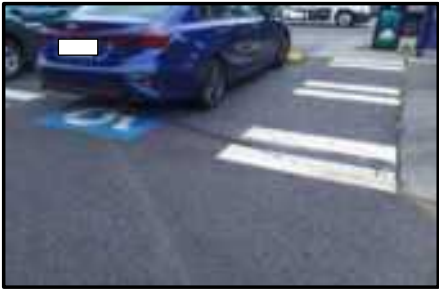
Parking Space Issue	Parking Space ID					Possible Solutions
	P1	P2	P3	P4	P5*	
Parking space not marked as accessible						
Parking space width is less than 96"						
Parking space does not have an adjacent access aisle						
Car parking space access aisle width is less than 60"	x	x	x	x	x	
Van parking space access aisle width is less than 96"						Remove and replace pavement markings
Access aisle does not extend the full length of the parking space it serves						
Access aisle is not marked to discourage parking in the aisle	x	x	x	x	x	Install access aisle hatch pavement markings
Access aisle overlaps the vehicular way						
Access aisle does not adjoin an accessible route						
Constrained width where the access aisle adjoins the accessible route is less than 48"						
Access aisle has change in level > 0.25"	x	x	x	x	x	
Access aisle has horizontal openings > 0.5"	x					Repave and restripe access aisle or relocate access aisle

Access aisle running slope is > 2%	x	x	x	x	x	
Access aisle cross slope is > 2%						
Parking space has change in level > 0.25"	x					
Parking space horizontal openings > 0.5"						
Parking space running slope is > 2%	x	x	x	x	x	Repave and restripe accessible parking space or relocate accessible parking space
Parking space cross slope is > 2%					x	
Parking space vertical clearance is < 98"						
Parking space identification sign is missing or incorrect

Note\* : Parking space #5 is bounded by two access aisles. While both aisles have deficient striping, only one is recommended to be re-striped.
