**King County**  
**ADA Self-Evaluation and Transition Plan Update**  
**Facility Cost Projection Summary**  
**August 2023**

# Site Accessibility Evaluation

**Burien PnR Garage (KC)**  
**14900 4th Ave SW**  
**Burien, WA 98166**  
**Accessibility Evaluation**  
**Inspection Date: 07/11/2023**  
**Evaluators: Kalia Klein**

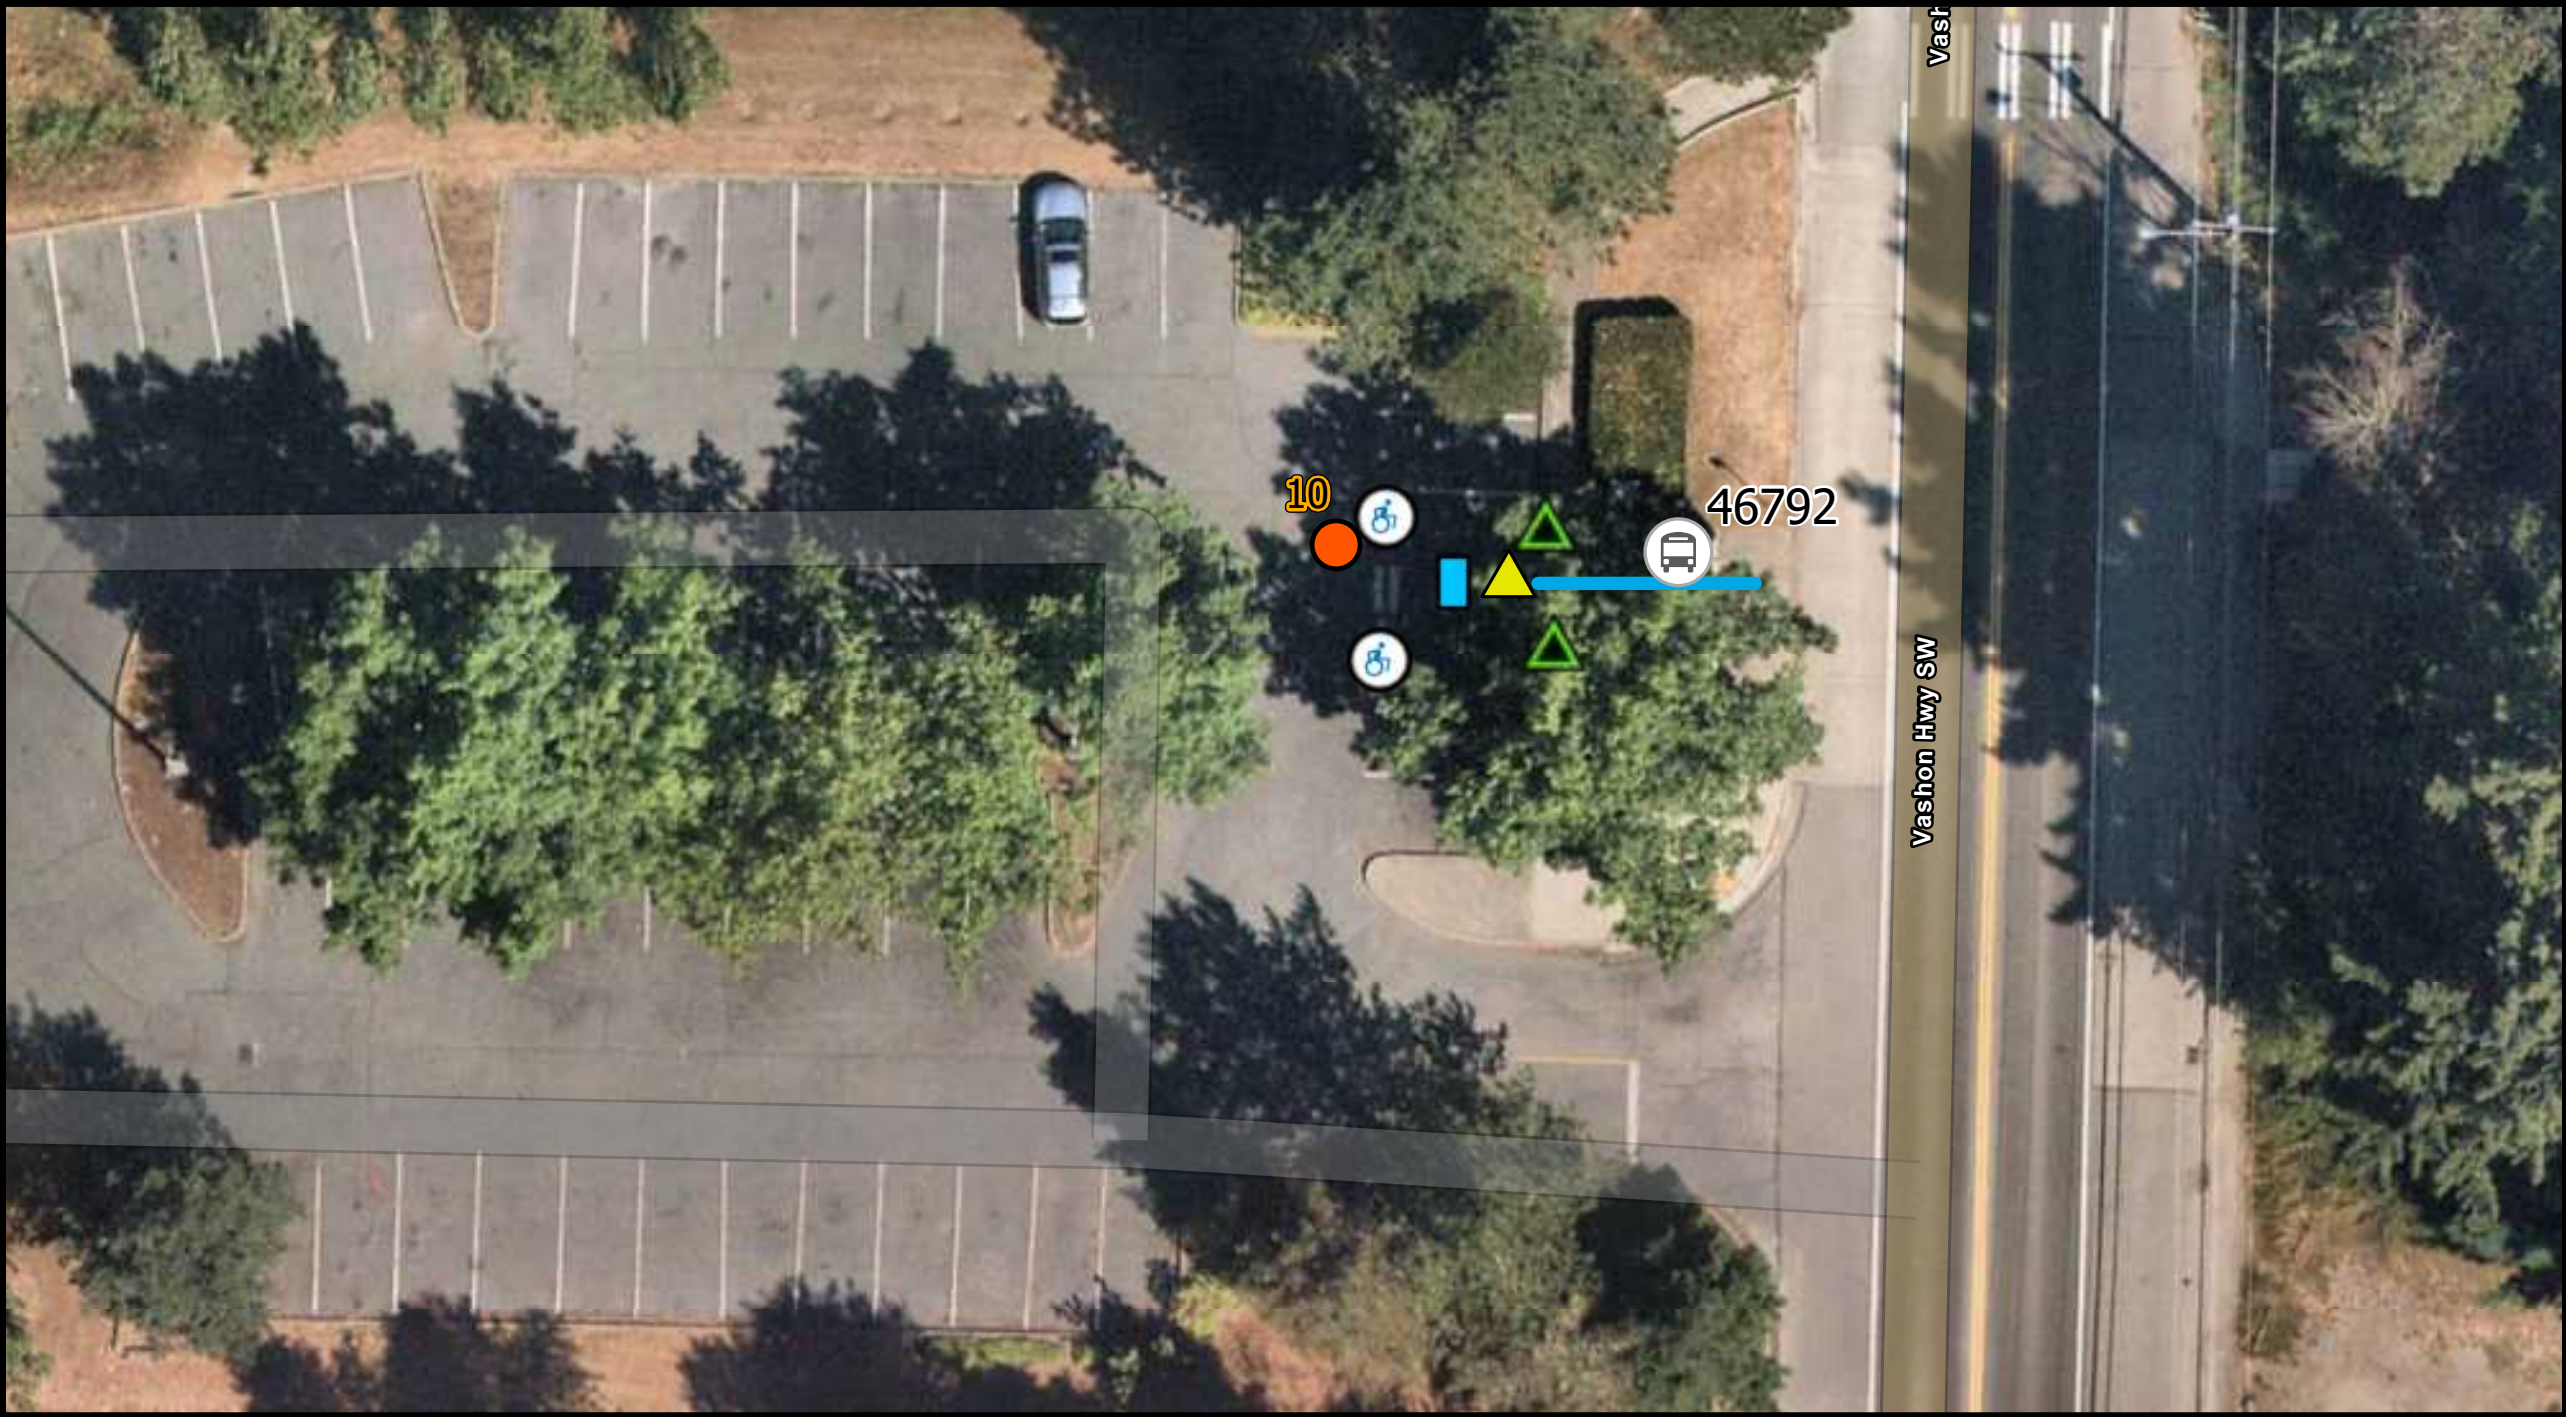
Feet
Path of Travel	24
	Quantity
Intersections with Curb Ramps	1
Ramps	0
Transit Stops	1
Accessible Parking Spaces	2

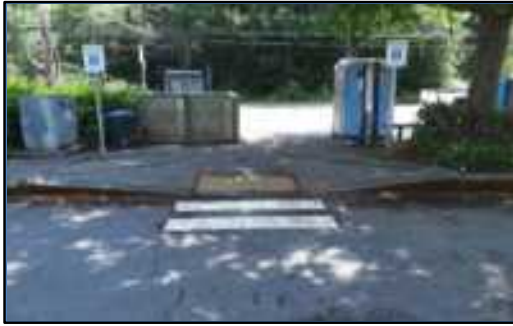
Ramp 4A

Issues	Point ID	Possible Solutions
	4A	
Curb ramp does not exist and is needed		
Curb ramp does not land in crosswalk		
No 4' x 4' clear space at base of curb ramp		
Curbed side is not 90° or has traversable adjacent surface		
Flare cross slope is greater than 10%	X	
Curb ramp running slope is greater than 8.3%		
Blended transition running slope is greater than 5%		
Cut-thru ramp running slope is greater than 5%		
Curb ramp cross slope is greater than 2%	X	
Cut-thru ramp cross slope is greater than 2%		
Curb ramp width is less than 48"		
Cut-thru ramp width is less than 60"		
Permanent obstruction (>0.25") in curb ramp/landing/flares	X	
Turning space does not exist and is needed		
Turning space length is less than 4' (or 5' when constrained)		
Turning space width is less than 4' (or 5' when constrained)		
Turning space running slope is greater than 2%	X	
Turning space cross slope greater than 2%	X	
Temporary obstruction (>0.25") in curb ramp/landing/flares	X

Non-compliant detectable warning surface (DWS)		
No detectable warning surface (DWS)		
Transition onto roadway is greater than 0.25"	X	Fix transition to roadway
Counter slope of the gutter or street at the foot of the curb ramp is greater than 5%		
Ponding occurs at base of curb ramp	X	Fix ponding

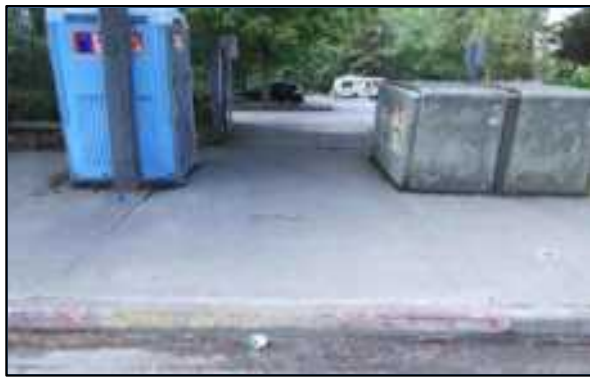
Boarding/Alighting Area

Boarding Area Issues	Issue Exists	Possible Solutions
Boarding area does not exist		
Boarding area length is less than 96"		
Boarding area width is less than 60"		
Boarding area running slope is greater than 2%	X	Remove and replace boarding area
Boarding area cross slope is greater than adjacent street grade		
Heaving/Sinking/Cracking present in the boarding area	X	
Ponding present in the boarding area		
Permanent obstruction (>0.25") in boarding area		
Temporary obstruction (>0.25") in boarding area		
Transition at connection to the curb is greater than 0.25"	X	Fix connection transition
Boarding area is missing a connection to the street or sidewalk network		
Adjacent Sidewalk Network Issues	Issue Exists	Possible Solutions
Sidewalk network width is less than 48"		
Sidewalk network cross slope is greater than 2%		
Heaving/Sinking/Cracking present in the sidewalk network		
Ponding present in the sidewalk network

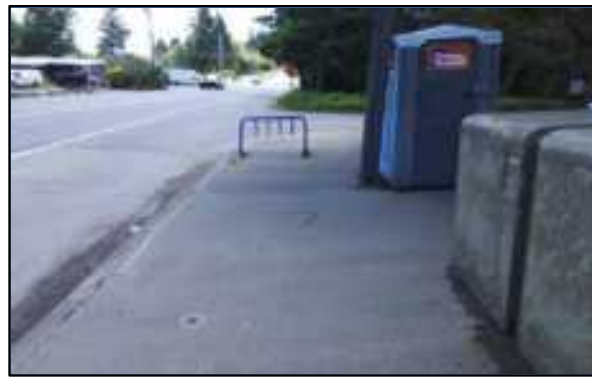
Adjacent Sidewalk Network

Permanent obstruction (>0.25") in sidewalk network		
Temporary obstruction (>0.25") in sidewalk network		
Transition at connection to boarding area is greater than 0.25"		
Transit Stop Sidewalk Issues	Issue Exists	Possible Solutions
Transit stop sidewalk cross slope is greater than 2%		
Heaving/Sinking/Cracking present in the transit stop sidewalk		
Ponding present in the transit stop sidewalk		
Permanent obstruction (>0.25") in transit stop sidewalk		
Temporary obstruction (>0.25") in transit stop sidewalk		
Transition at connection to sidewalk network is greater than 0.25"		
Transit Stop Amenity Issues	Issue Exists	Possible Solutions
No transit stop signage		
Transit stop signage is non-compliant	X	Remove and replace transit stop signage
No clear space adjacent to stand-alone bench		
Stand-alone bench clear space length is less than 48"		
Stand-alone bench clear space width is less than 30"		
Stand-alone bench clear space running slope is greater than 2%

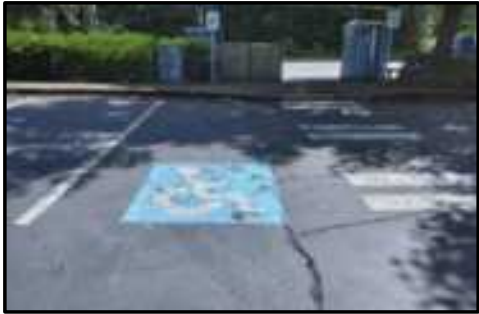
Parking Space ID 1

Parking Space Issue	P1	P2	Parking Space ID	Possible Solutions
Parking space not marked as accessible	x	x		
Parking space width is less than 96"				
Parking space does not have an adjacent access aisle				
Car parking space access aisle width is less than 60"				
Van parking space access aisle width is less than 96"				
Access aisle does not extend the full length of the parking space it serves				
Access aisle is not marked to discourage parking in the aisle	x			Install access aisle hatch pavement markings
Access aisle overlaps the vehicular way				
Access aisle does not adjoin an accessible route				
Constrained width where the access aisle adjoins the accessible route is less than 48"				
Access aisle has change in level > 0.25"	x			
Access aisle has horizontal openings > 0.5"	x			Repave and restripe access aisle or relocate access aisle
Access aisle running slope is > 2%	x			
Access aisle cross slope is > 2%

Parking space has change in level > 0.25"	x	x		
Parking space horizontal openings > 0.5"	x	x		
Parking space running slope is > 2%	x	x		Repave and restripe accessible parking space or relocate accessible parking space
Parking space cross slope is > 2%				
Parking space vertical clearance is < 98"				
Parking space identification sign is missing or incorrect

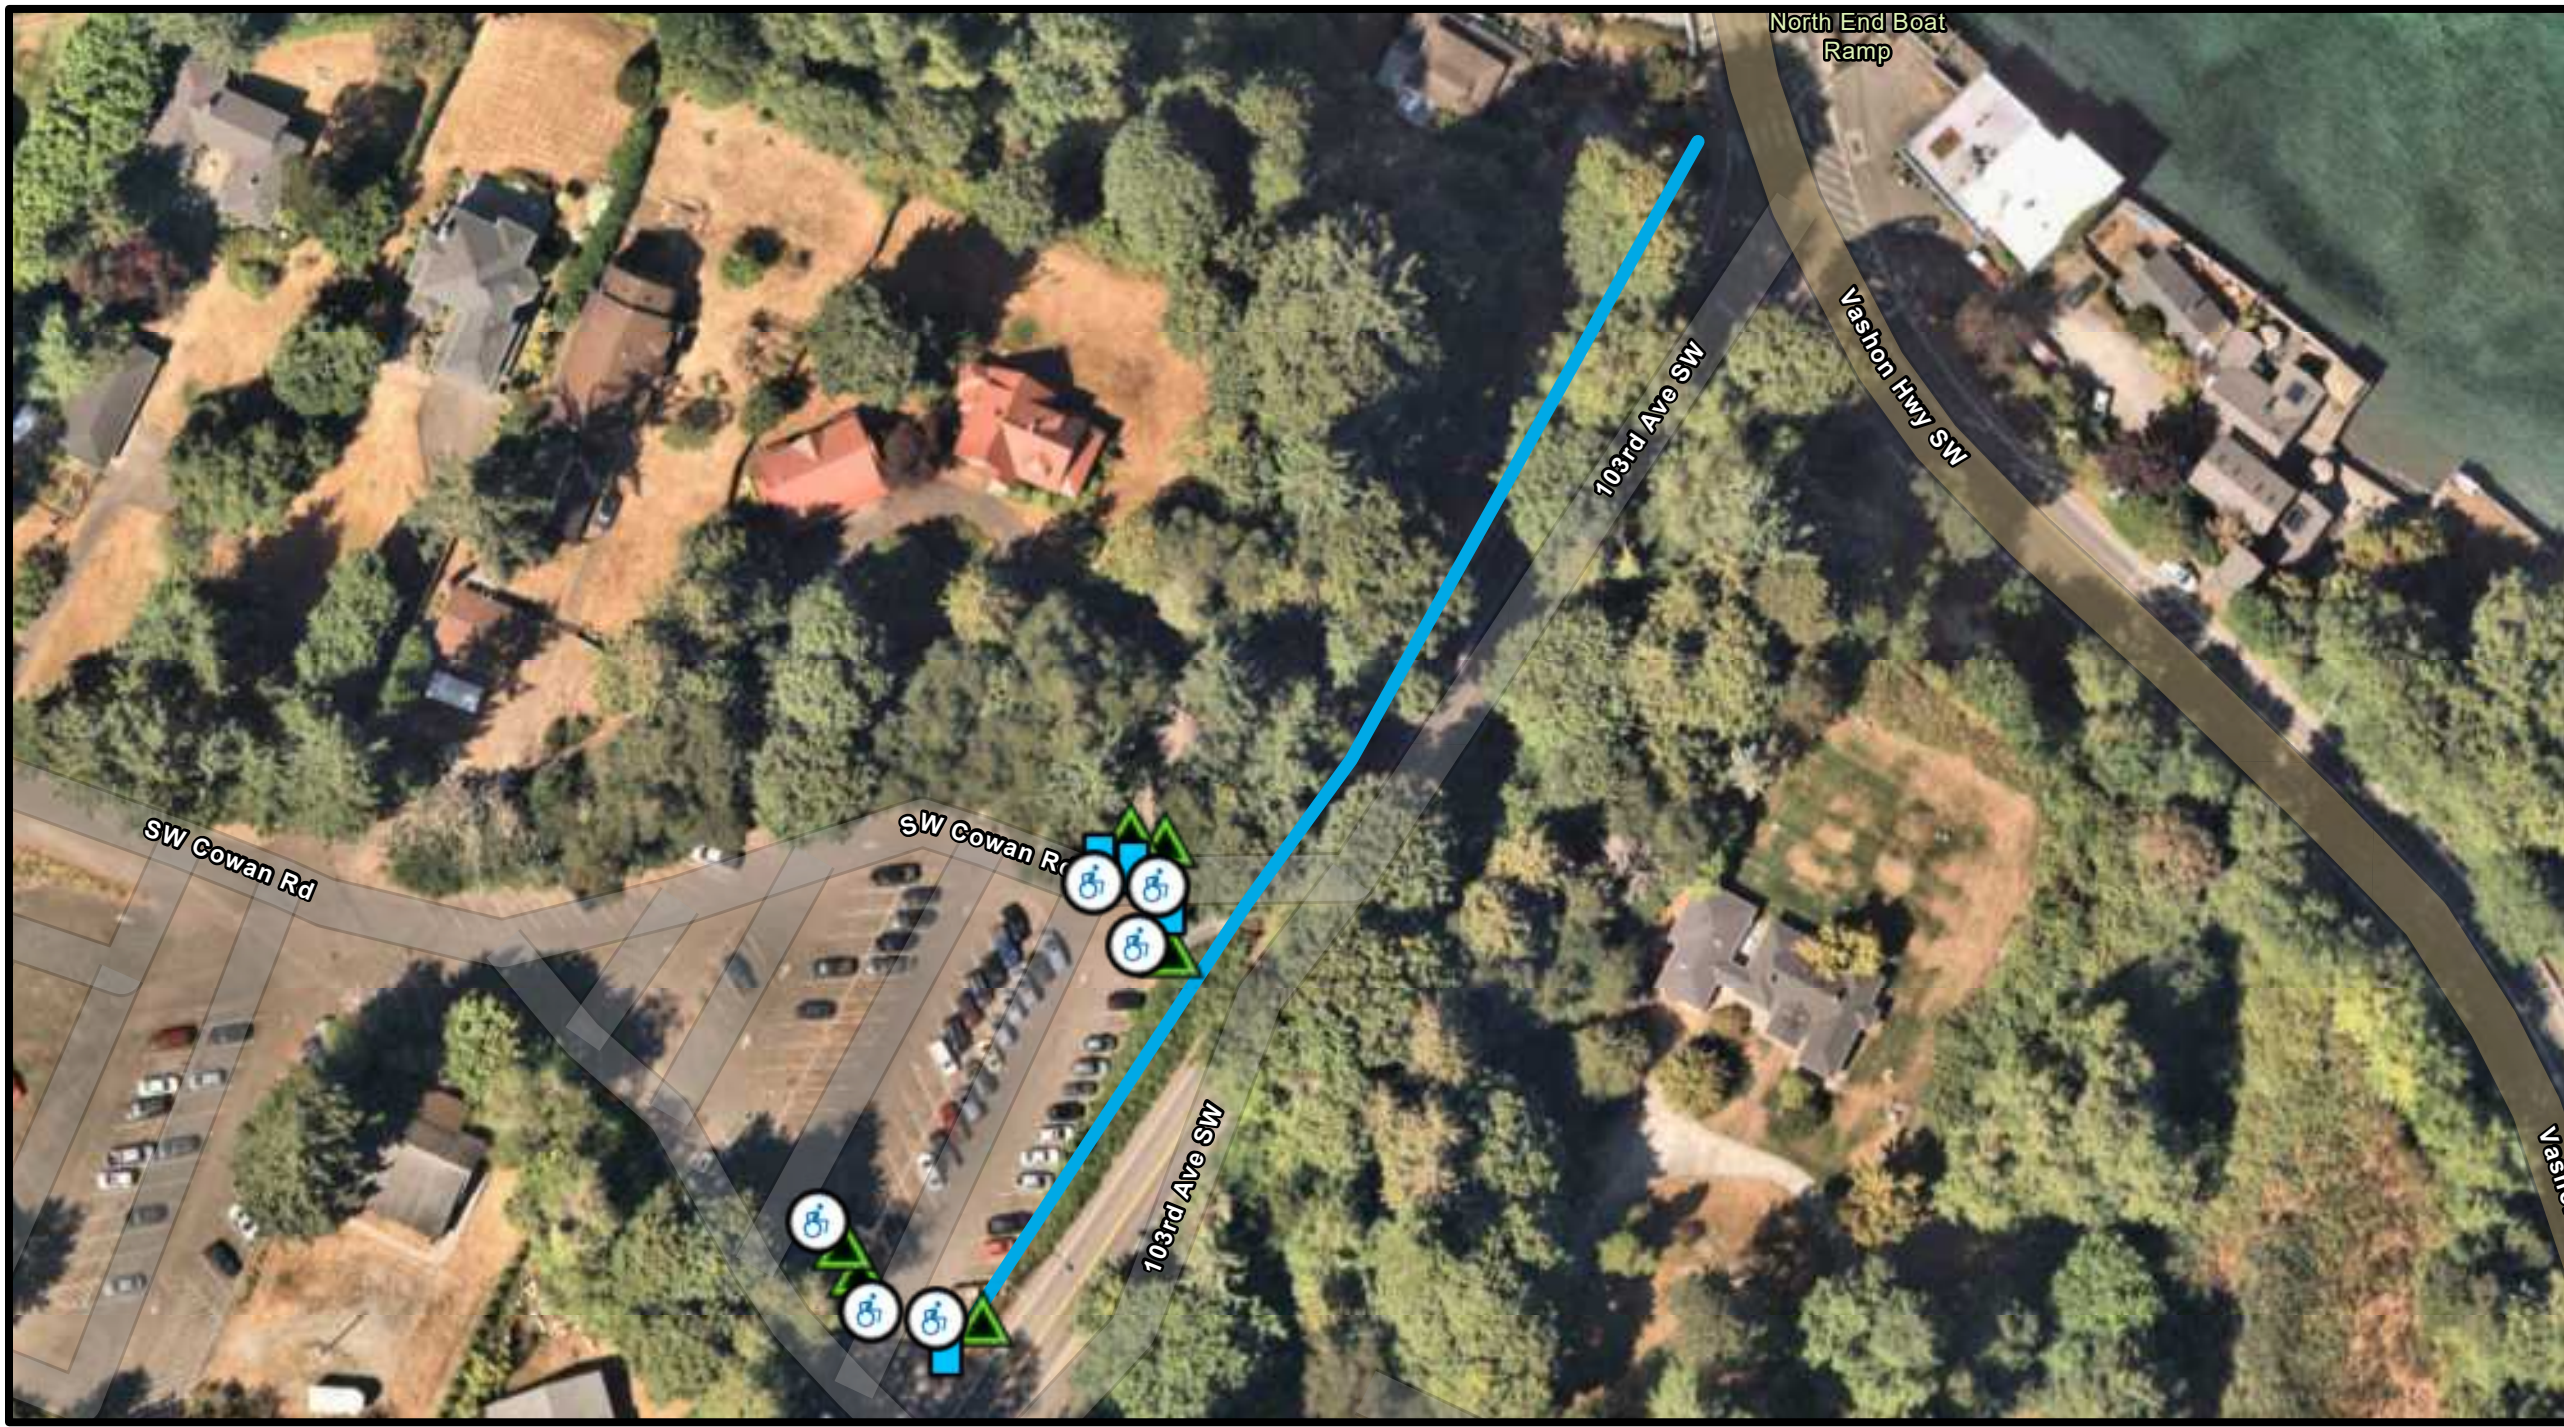
Facility Quantity Summary of Evaluated Elements	
	Feet
Path of Travel	560
	Quantity
Intersections with Curb Ramps	0
Ramps	0
Transit Stops	0
Accessible Parking Spaces	6

Facility Estimated Cost of Improvements	
Path of Travel	\$35,700.00
Intersections with Curb Ramps	\$0.00
Ramps	\$0.00
Transit Stops	\$0.00
Accessible Parking Spaces	\$75,000.00
Total Estimated Cost of Improvements	\$110,700.00

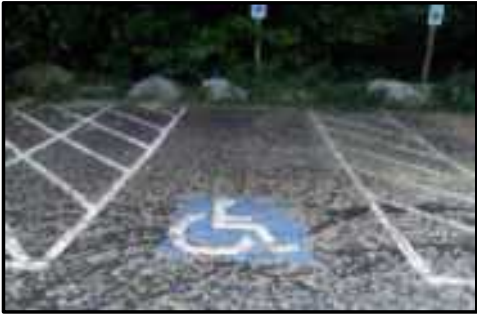
Parking Space ID 1

Parking Space Issue	Parking Space ID						Possible Solutions
	P1	P2	P3	P4	P5	P6	
Parking space not marked as accessible		x	x	x	x	x	Install International Symbol of Accessibility Striping
Parking space width is less than 96"							
Parking space does not have an adjacent access aisle					x	x	Install access aisle pavement markings
Car parking space access aisle width is less than 60"							
Van parking space access aisle width is less than 96"							
Access aisle does not extend the full length of the parking space it serves							
Access aisle is not marked to discourage parking in the aisle				x			Install access aisle hatch pavement markings
Access aisle overlaps the vehicular way							
Access aisle does not adjoin an accessible route	x	x		x			Remove and replace pavement markings
Constrained width where the access aisle adjoins the accessible route is less than 48"							
Access aisle has change in level > 0.25"

Access aisle has horizontal openings > 0.5"							
Access aisle running slope is > 2%	x	x	x	x			Repave and restripe access aisle or relocate access aisle
Access aisle cross slope is > 2%	x	x	x				
Parking space has change in level > 0.25"			x				
Parking space horizontal openings > 0.5"							
Parking space running slope is > 2%	x	x	x	x	x	x	Repave and restripe accessible parking space or relocate accessible parking space
Parking space cross slope is > 2%	x	x	x	x	x	x	
Parking space vertical clearance is < 98"							
Parking space identification sign is missing or incorrect					x	x	Install accessible parking sign
