King County Initial Infiltration and Inflow Reduction Project Alternatives Analysis Report

APPENDIX A. ENVIRONMENTAL TECHNICAL MEMORANDUM

Environmental Technical Memorandum King County Inflow and Infiltration Basin Study King County, Washington

KING COUNTY INFLOW AND INFILTRATION PROJECT STUDY ENVIRONMENTAL TECHNICAL MEMORANDUM

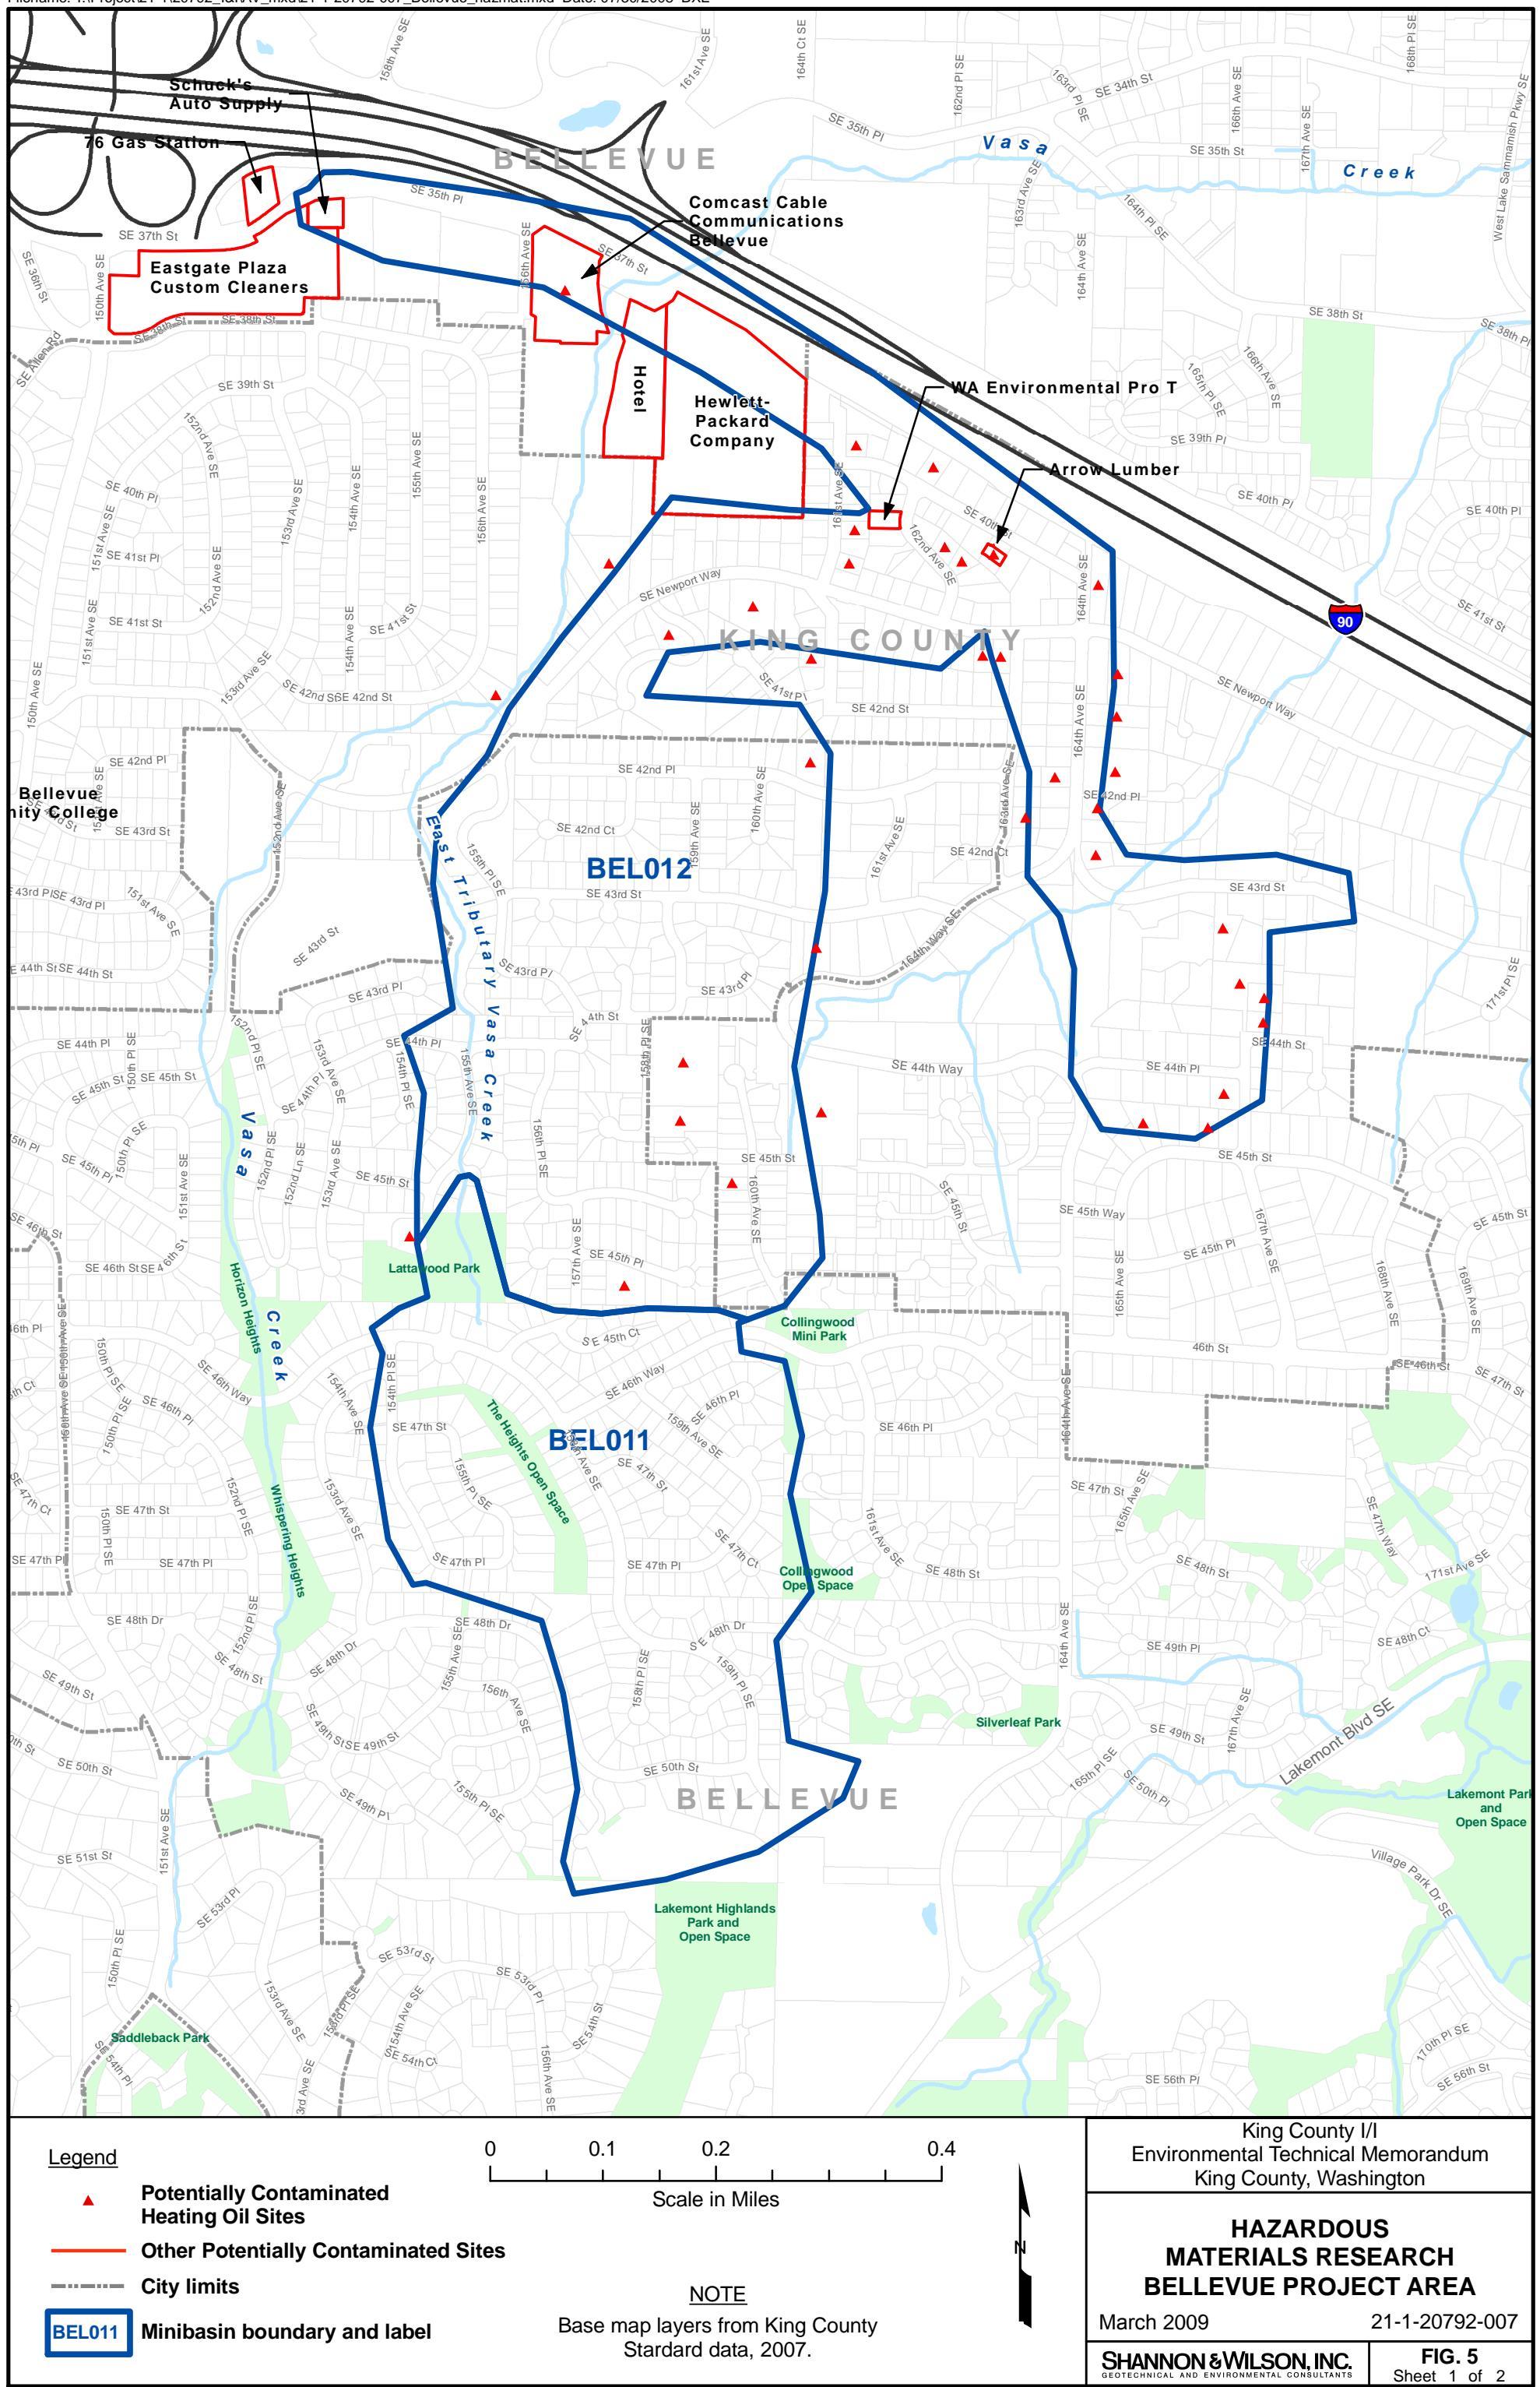
Filename: T:\Project\21-1\20792_I&I\AV_mxd\21-1-20792-007_Bellevue_hazmat.mxd Date: 07/22/2008 BXE

Businesses, including gas stations and automobile repair shops developed since approximately 1988; construction companies with no known USTs; and residences with heating oil tanks are considered to have a **low** potential to impact the project area. Newer gas stations are considered to have a **low** contamination potential because of the implementation of stringent regulations for UST construction, system installation, monitoring, and testing. Although construction companies frequently have USTs, such companies are considered to pose a **low** potential for contamination where the presence of USTs has not been confirmed. Properties with heating oil tanks are considered to have a **low** potential because heating oil generally does not travel far in soil. The locations of the identified properties that have a potential to impact to soil in the vicinity of the sewer line are indicated in Figure 5.

- Tosco Corporation Site 2564273, 15220 SE 36th Place, Bellevue (CSCSL NFA, VCP, ICR, FINDS, RCRA-SQG). The database information indicates that petroleum-contaminated soil was observed during the removal of three USTs in 1998. Following remediation, Ecology issued a NFA status (5/12/2005). Site soil has been remediated and groundwater was reportedly not affected. Therefore, the site is evaluated to have a low potential to impact the project area.

- Eastgate Plaza 24 Hour Custom Cleaner, 15100 SE 38th Street, Bellevue (FINDS, RCRA, Inactive Drycleaner). The drycleaner in the Eastgate Plaza shopping center is listed on databases that indicate hazardous chemicals are or were stored on site. A gas station is also located on this property but is not considered a risk to the project because it is located 1,000 feet to the east. Although the dry cleaner is not listed on a database that would indicate that a release of hazardous materials has occurred, the property is still considered to have a moderate potential to impact the project area because dry cleaning fluids (solvents) are highly toxic at low concentrations.

- Hewlett-Packard Company, 15815 SE 37th Street, Bellevue (UST, RCRA-SQG, CSCSL NFA, VCP, ICR, FINDS). The database information indicates that five USTs were removed from the site. Petroleum products and metals-impacted soil and groundwater were observed during UST removal. Following remediation, Ecology issued a NFA status (4/27/2000). Site soil and groundwater have reportedly been remediated; however, the site is evaluated to have a moderate potential to impact the project area.
