Department of Natural Resources and Parks

Restoring the West Point Treatment Plant

Mark Isaacson, Director Wastewater Treatment Division March 18, 2017

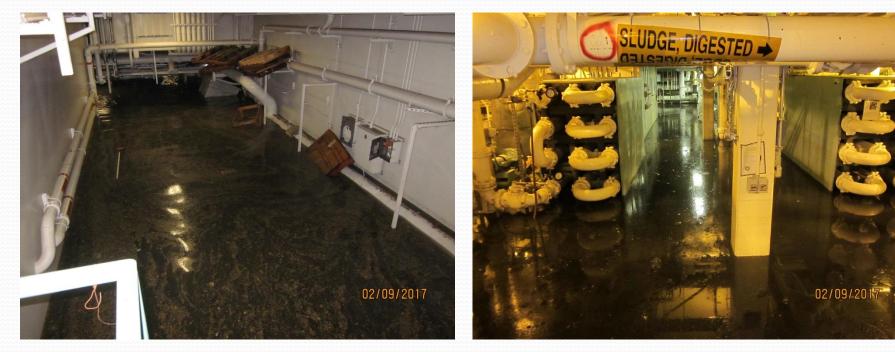
Flooded galleries

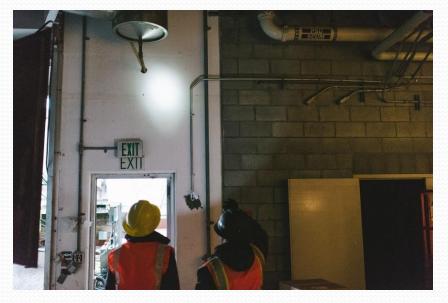
Flashlight shows water line

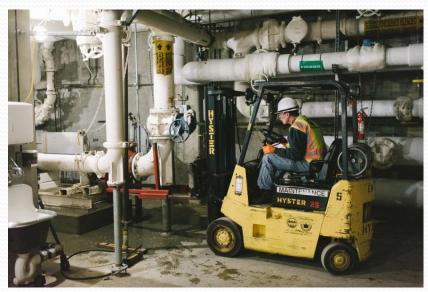
Underground gallery

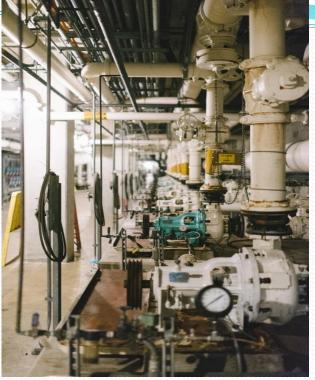
Twin Equipment Control Panels – Cleaned, inspected, and ready for repair/replacement

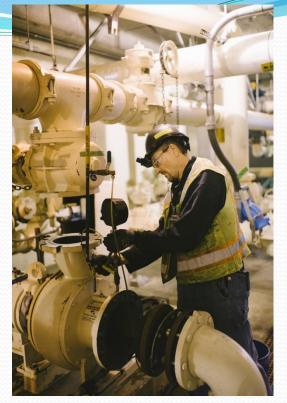
Gravity Belt Thickener Feed Pumps - Ready for replacement motors

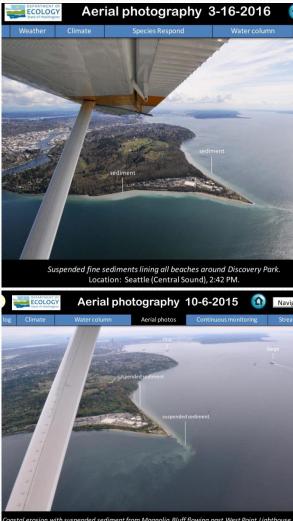
- Seattle Times photo from 3/12 story Not bypass-related
 - No seagulls
 - Bacteria counts not consistent with large bypass
 - Seven hours after bypass stopped
 - Sediment plumes off West Point are normal

Coastal erosion with suspended sediment from Magnolia Bluff flowing past West Point Lighthouse. Location: West Point Lighthouse, Seattle (Central Sound), 2:29 PM.
