**King County Department of Natural Resources and Parks
Wastewater Treatment Division**

Equity and Social Justice Review of Facilities

November 2013

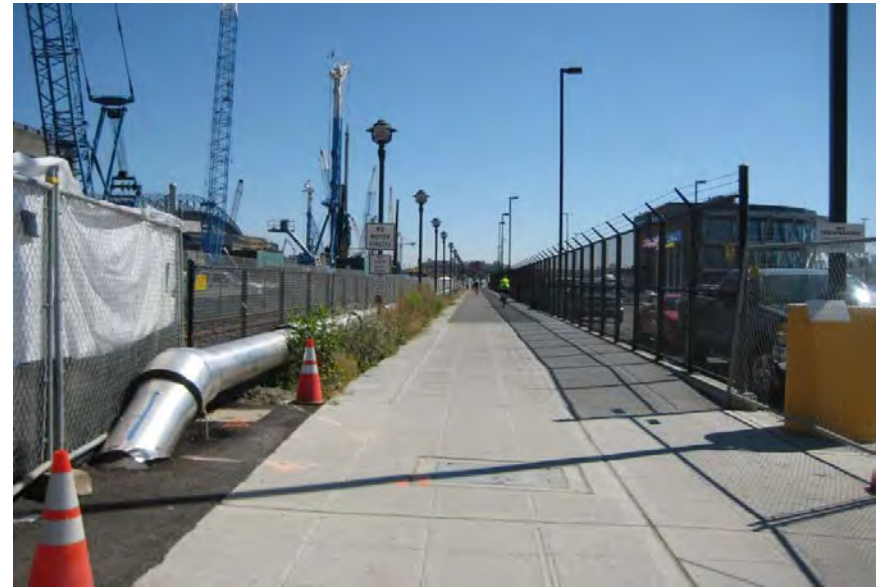
Adjacent public trail extending around Elliot Bay to West Seattle

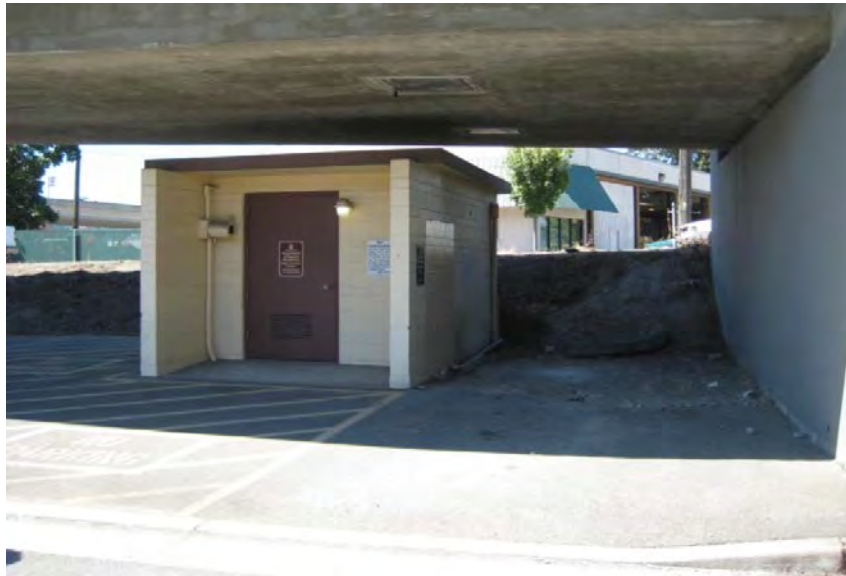
View from the south to the north from adjacent roadway

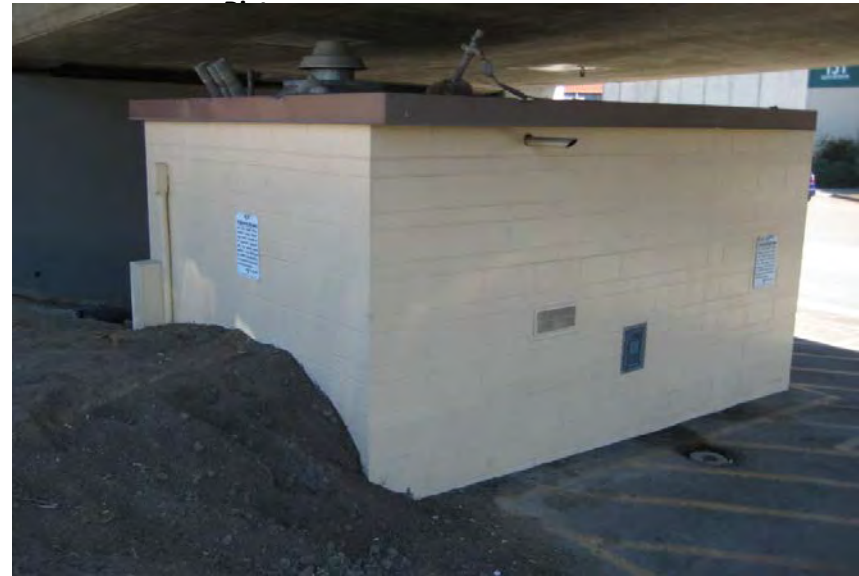
Back and side view of facility (north and west facades)

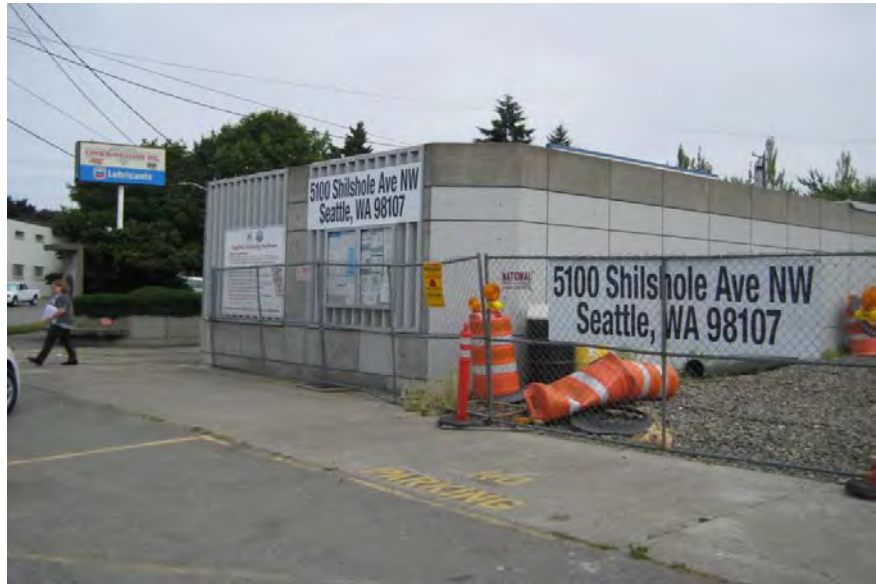
View into the site from the adjacent roadway

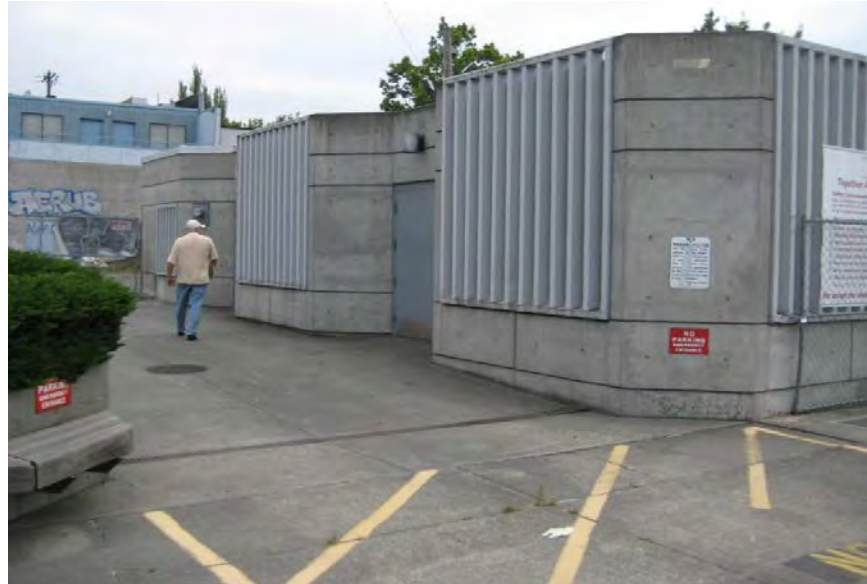
View along western edge of facility

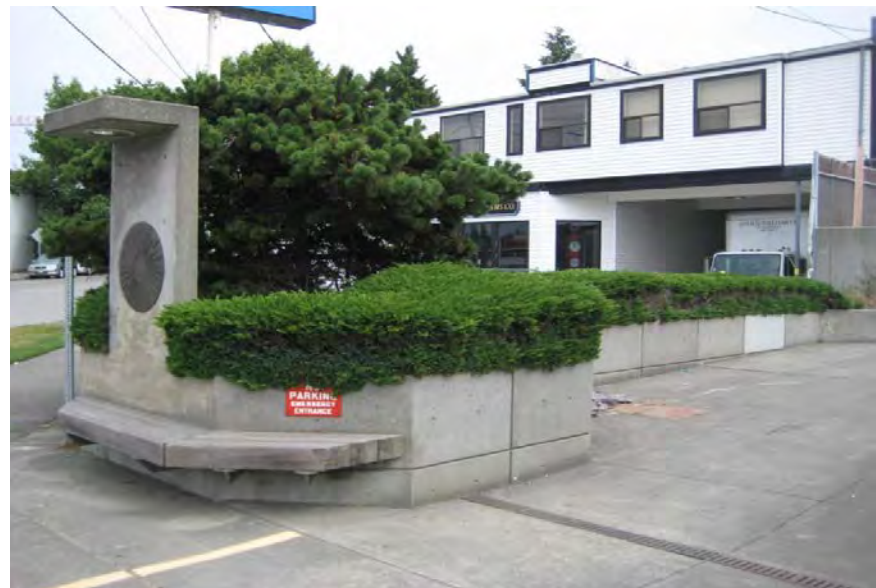
Side view to the landscape and public seating area

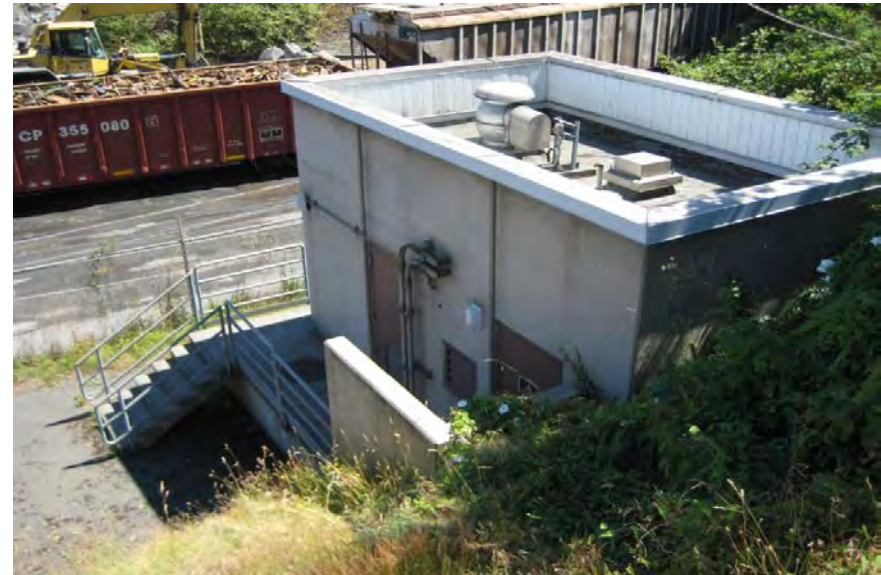
View into the site over the fence from the sidewalk

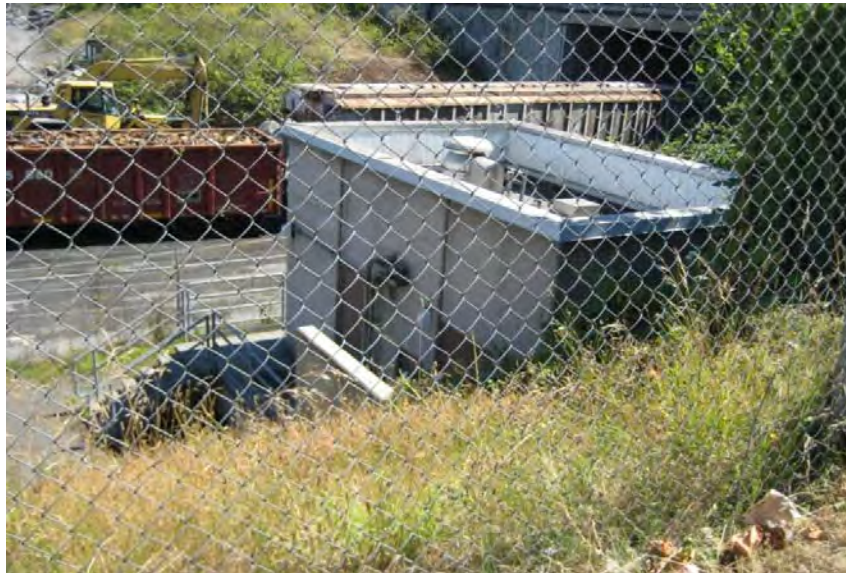
View from pedestrian walkway to the west of facility

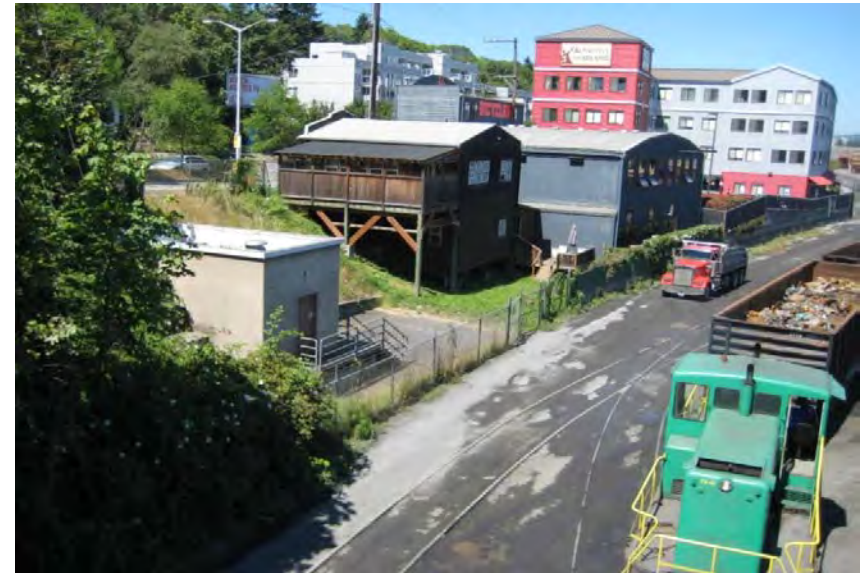
View from the south to the north showing the east elevation of the facility
