JUNE 2015

**EQUITY AND SOCIAL JUSTICE
REVIEW OF FACILITIES:**
ASSESSMENT OF RESIDENTIAL-AREA
PUMP STATIONS

King County

Department of Natural Resources and Parks
Wastewater Treatment Division

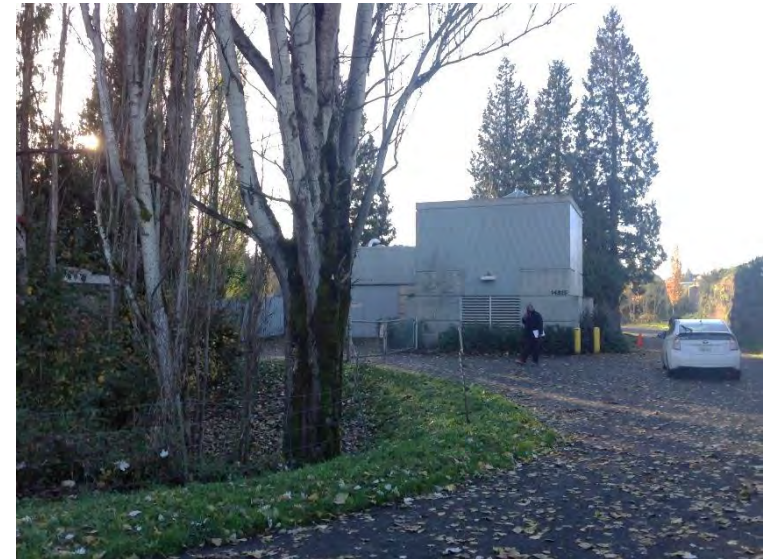
View of Hollywood Pump Station from the access road; note some barbed wires on the left

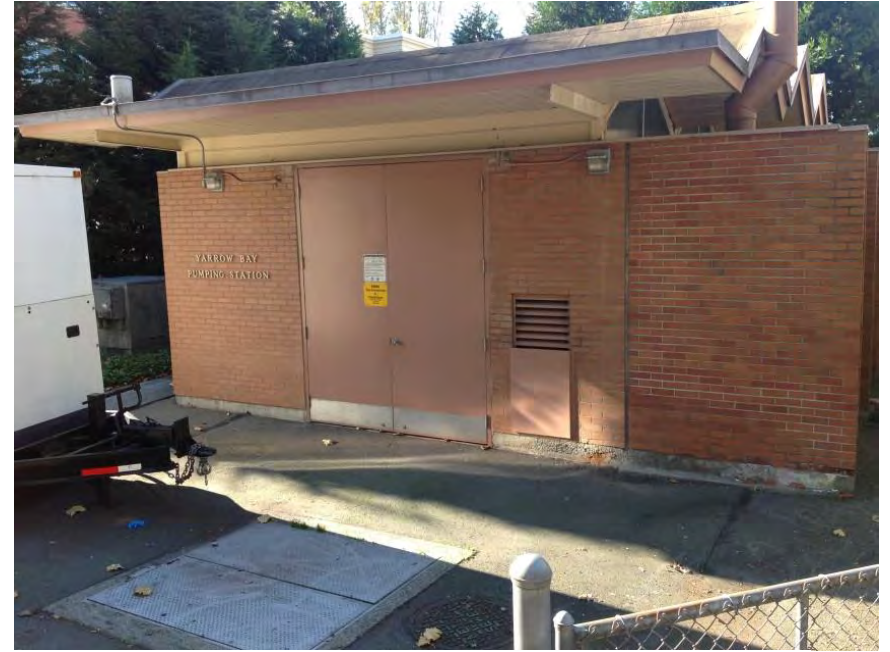
Front entry to Yarrow Bay Pump Station

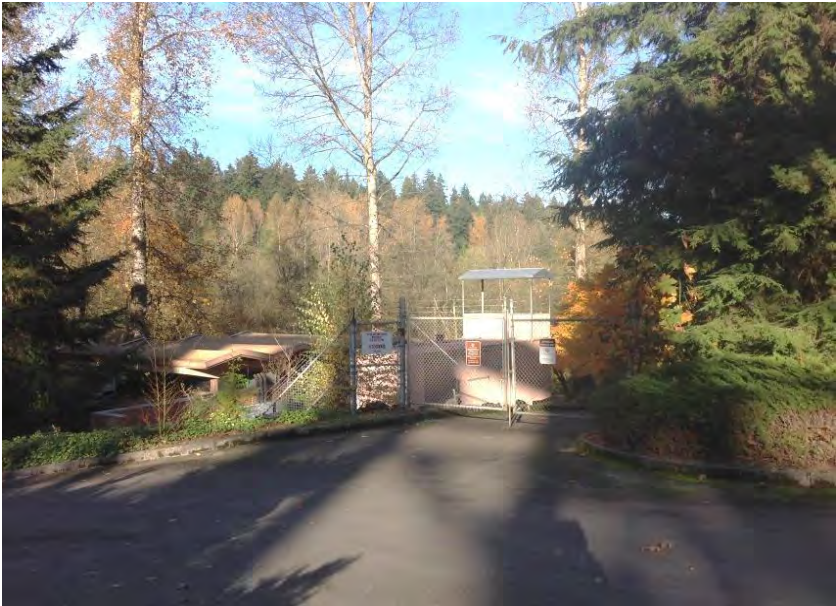
Street view of Wilburton Pump Station

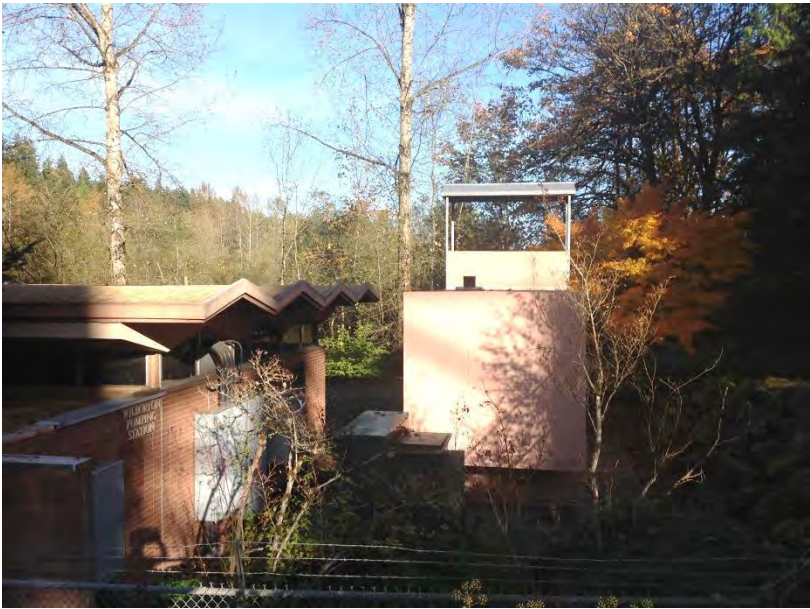
View to the pump station from the entry roadway.

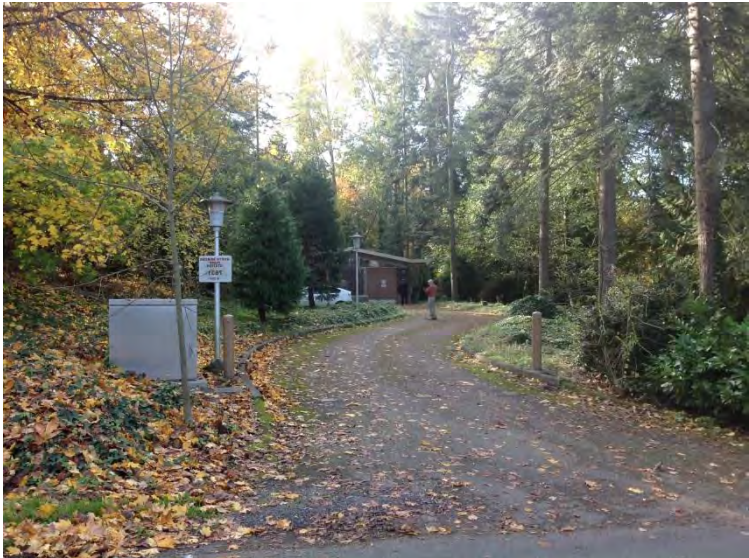
View down the entryway to North Mercer Pump Station.

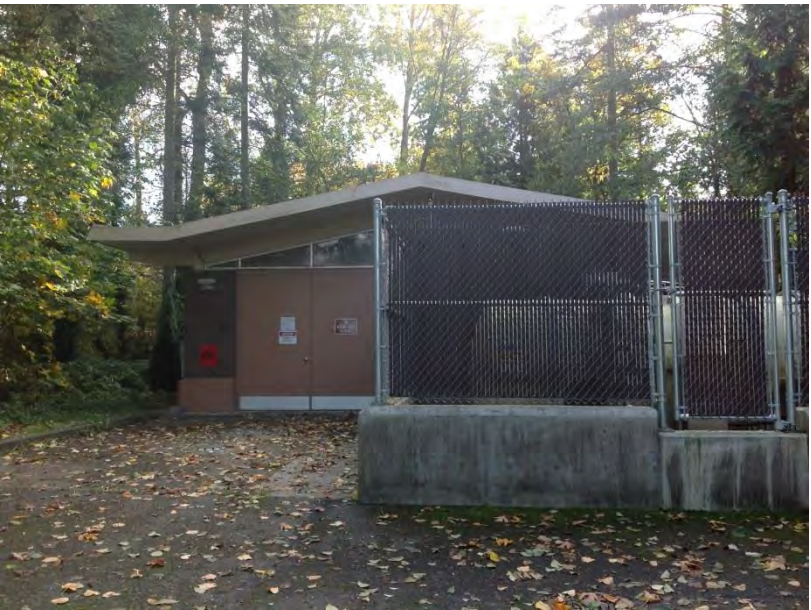
Front doors and fenced-area of North Mercer Pump Station.

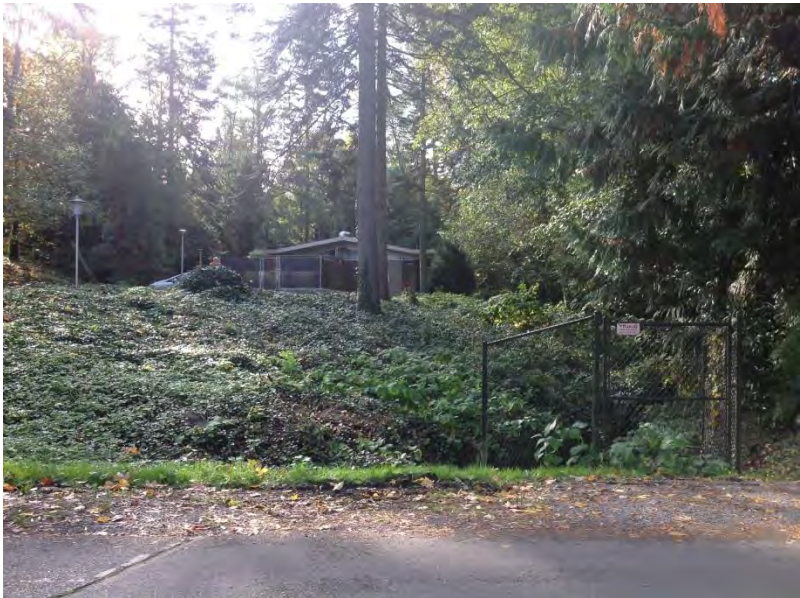
Street view, note invasive species encroaching into woodlands.

English Ivy is a Class C Noxious Weed, and should be removed from any facility where it cannot be kept to strictly confined areas. When replaced, ivy should be replaced with a non-invasive ground cover.

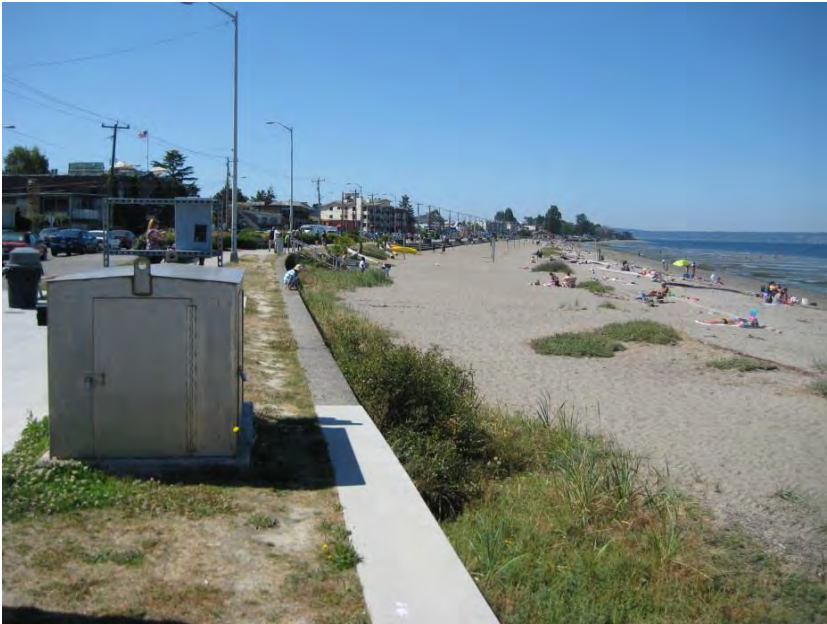
View to the west showing small electrical vault.

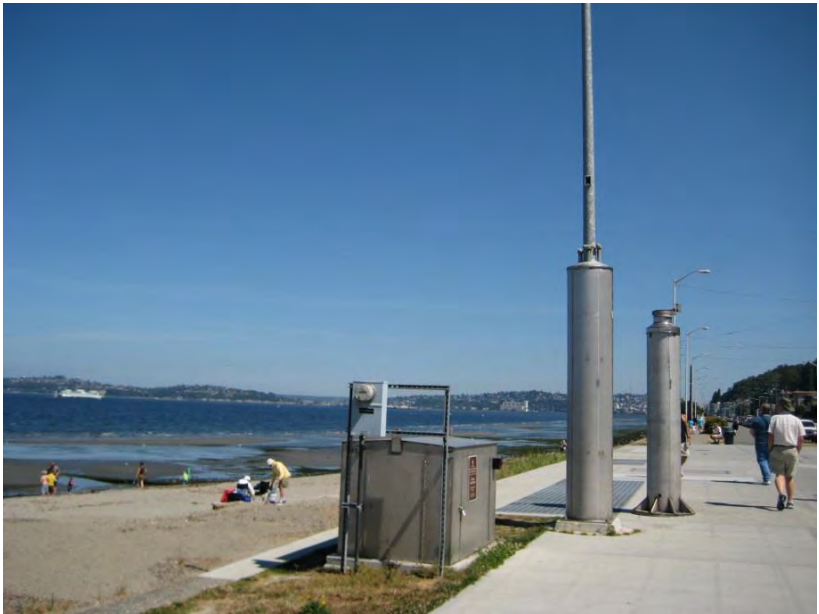
View of the exhaust stacks, electrical vault and public walkway on top of the pump station.

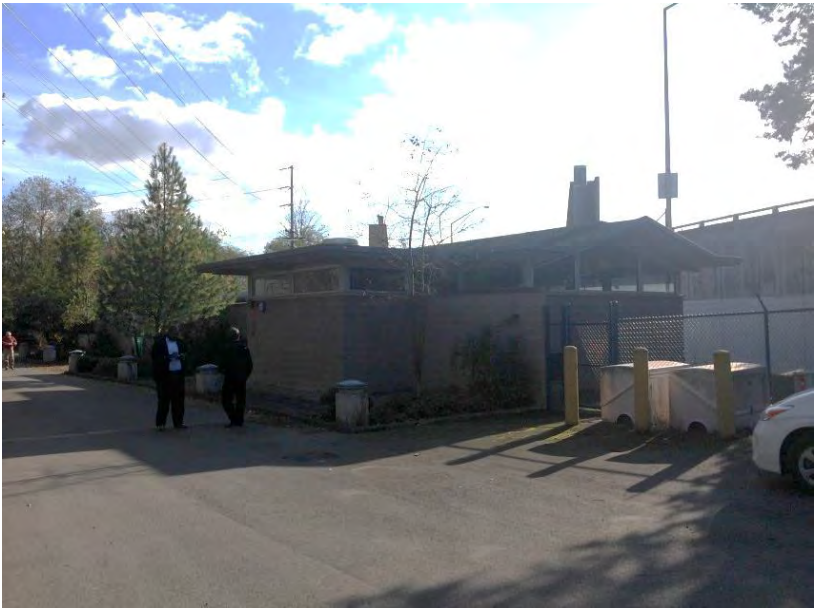
View from the park looking south to the pump station.

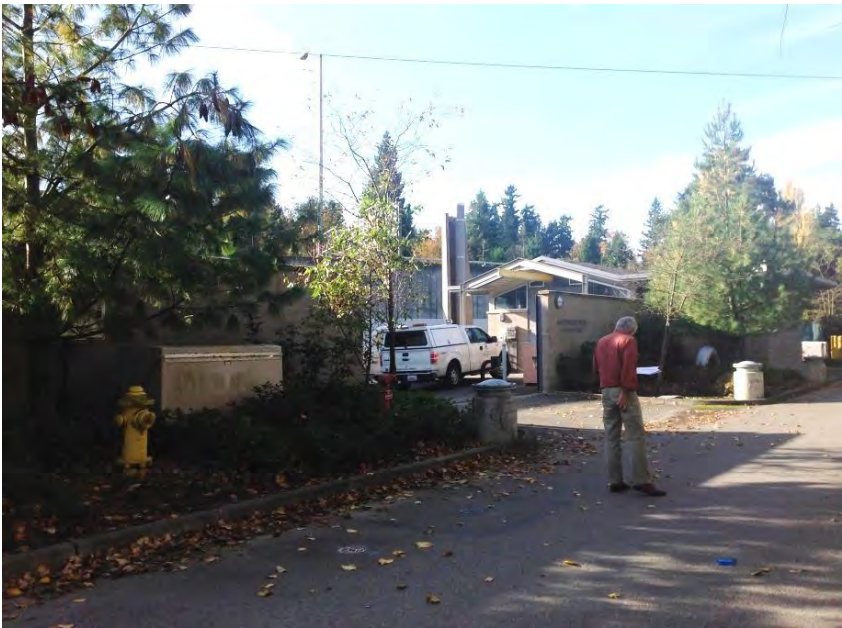
View from the park looking north at the facility.

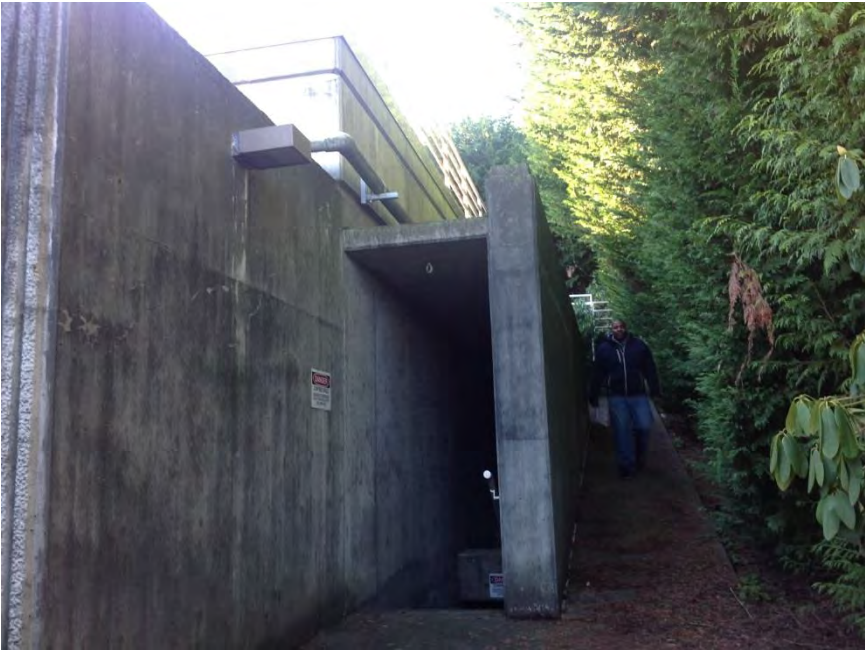
Side view of pump station, leading to rooftop and roadway.

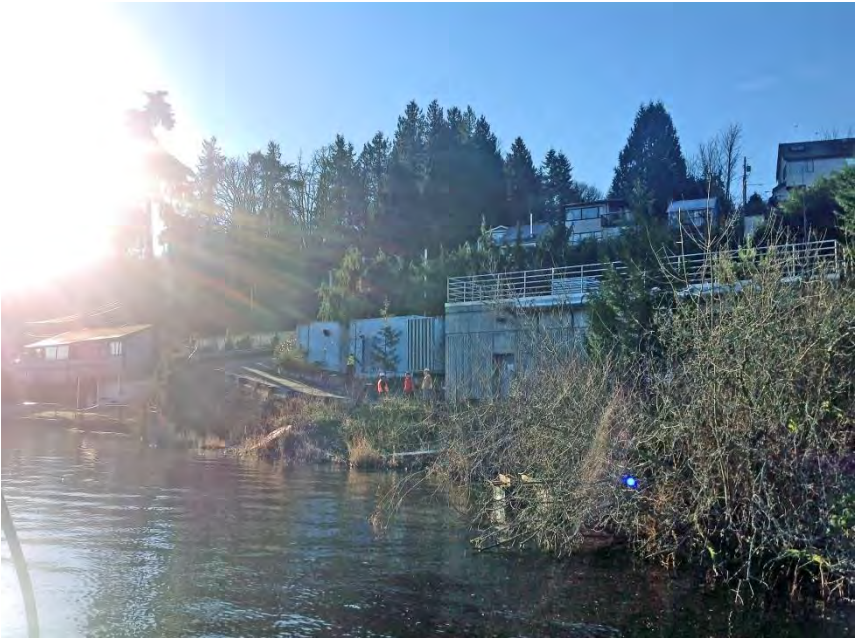
View of facility from adjacent dock.

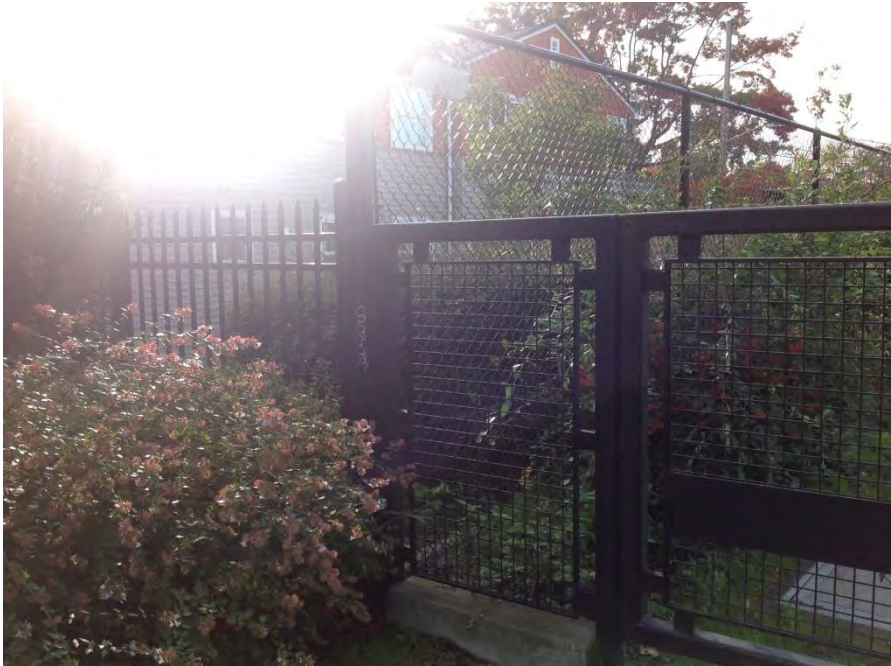
View of fence line and neighboring property.

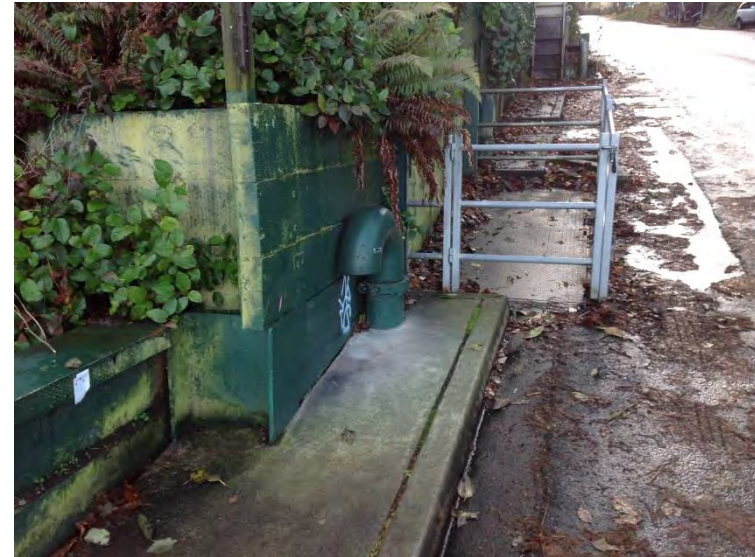
Characteristic	Score	Type	Comments
<i>Aesthetic and Art</i>			
Quality of maintenance on landscape	1	M	
Presence and extent of art	0	D	
Quality of landscape installation	1	D	Built retaining wall on facility #1, falling apart in the corner.
Views into the site	1.25	D	Un-buffered, industrial unfiltered
<i>Building</i>			
Level of architectural finish	1	D	Green painted wall north end falling apart
Physical conditions of overall facility	2.5	M	Vault and metal utility boxes.
<i>Facility</i>			
Noticeable odor	4.5	O	None.
Public amenities (on-site)	0	D	None.
Effectiveness of public safety measures	1.25	D	Rail around vault/only safety feature
General overall impression	2.5	Fact	Boxes and vaults besides roads
<i>Surroundings</i>			
Effect on regional view	2.5	D	Nothing to look at
View blockage by facility	4.5	D	Tucked into hillside
Intrusiveness of lighting (trespass and noise)	4.25	D	None.
Noise originating from facility	4.25	D	None.

View of retaining wall structure and hand rail at the north end of the series of four pump stations.

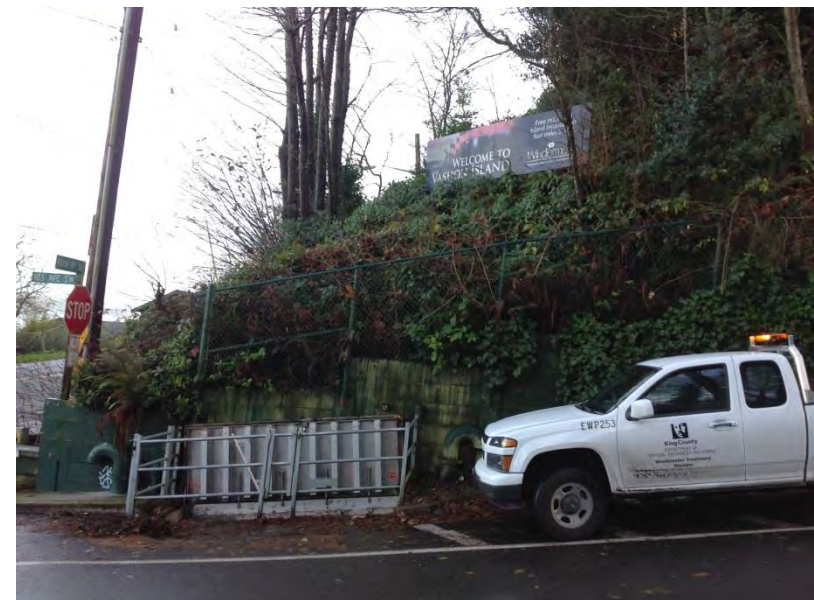
Open vault, occupied by O&M crews, at the north end of the facilities.

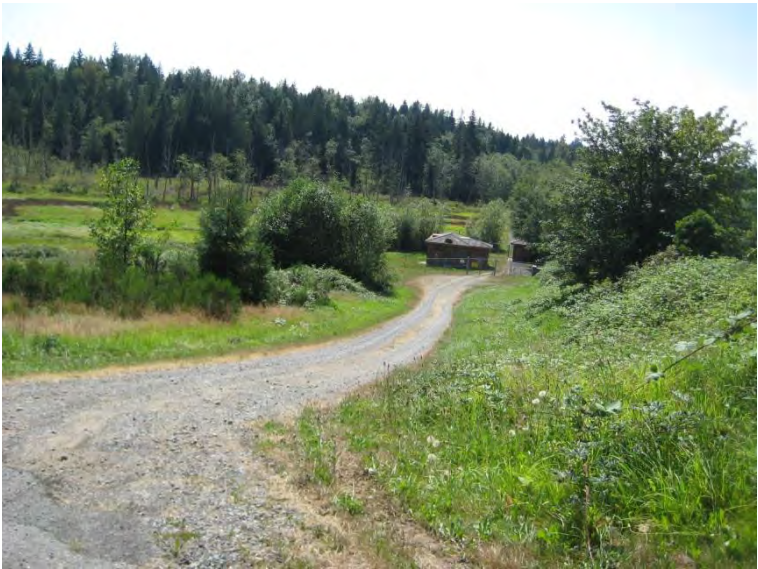
Characteristic	Score	Type	Comments
Aesthetic and Art			
Quality of maintenance on landscape	2	M	Only grass (some overgrown) around the site. Right next to a wetland. Should be landscaped.
Presence and extent of art	0	D	None.
Quality of landscape installation	2	D	Low, only grass installed. Missed opportunity to enhance adjacent wetland area.
Views into the site	3	D	Limited visibility. Visible only from the road, tucked in with a long driveway.
Building			
Level of architectural finish	3	D	Good. Possibly copper roofing on dormers. Brick building.
Physical conditions of overall facility	3	M	Good for the building (4 locks to secure the fence. Fencing seems excessive, could be reduced.
Facility			
Noticeable odor	3	O	None.
Public amenities (on-site)	0	D	None.
Effectiveness of public safety measures	2	D	Fencing is excessive, intrusion alarms seem unnecessary.
General overall impression	2.5	Fact	Nice building, good location. Needs landscaping, low hum heard when pump is working.

The view into the site, down the entry roadway to the pump station from roadway.

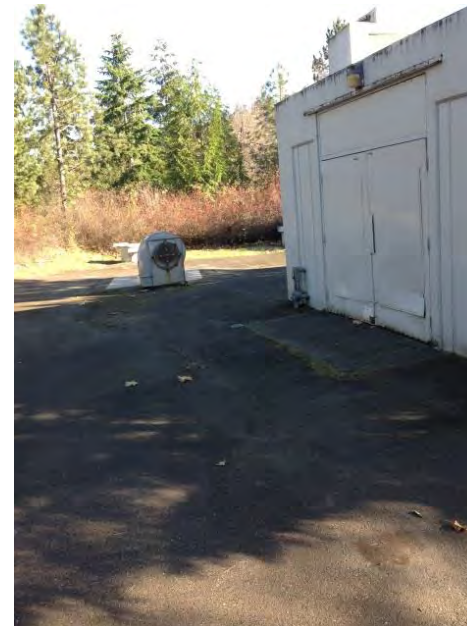
Note the dented door on the box.
North elevation on the pump station building.
