Subject: North Beach Force Main Evaluation

**TETRA TECH, INC.
KING COUNTY WTD
NORTH BEACH FORCE MAIN
CONDITION ASSESSMENT PROJECT
FINAL REPORT**

Norton Corrosion Limited (NCL) was retained by Tetra Tech, Inc. to assist with a condition assessment of King County WTD North Beach Force Main located in Seattle, Washington. NCL developed an inspection/sampling program to be conducted at select excavation sites with field activities to collect necessary data and laboratory analysis to support formation of a professional opinion on present conditions. Authorization was by Consulting Services Agreement dated September 5, 2012. The field portion of the inspection/sampling occurred during the week of August 17, 2012.

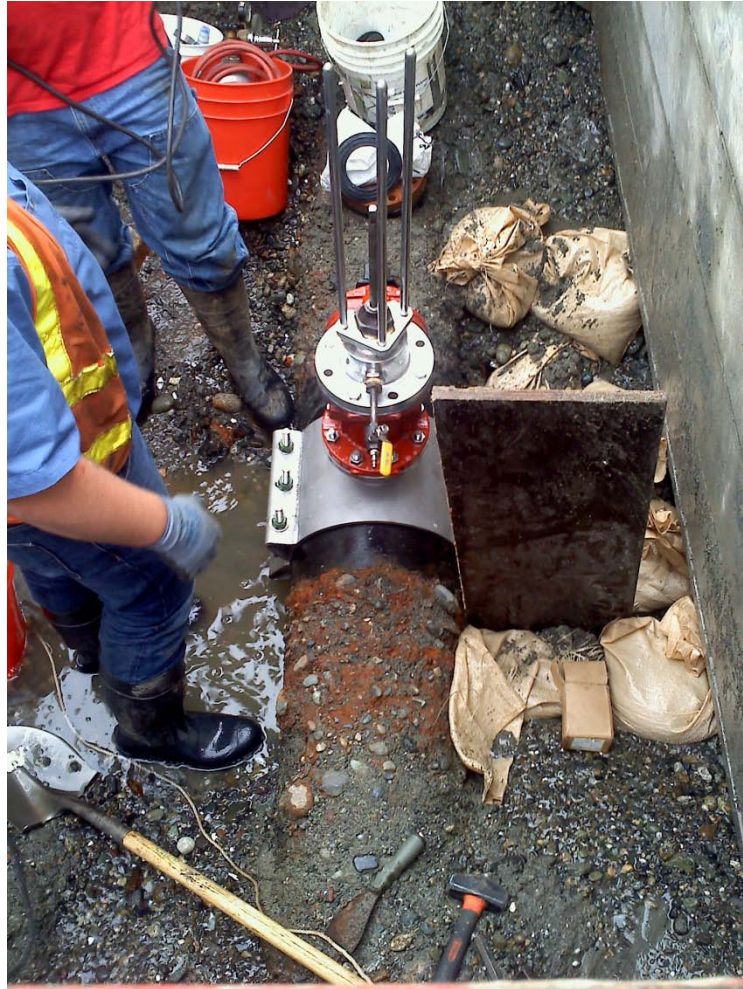
Picture 1-7: Clamp and Tapping Machine

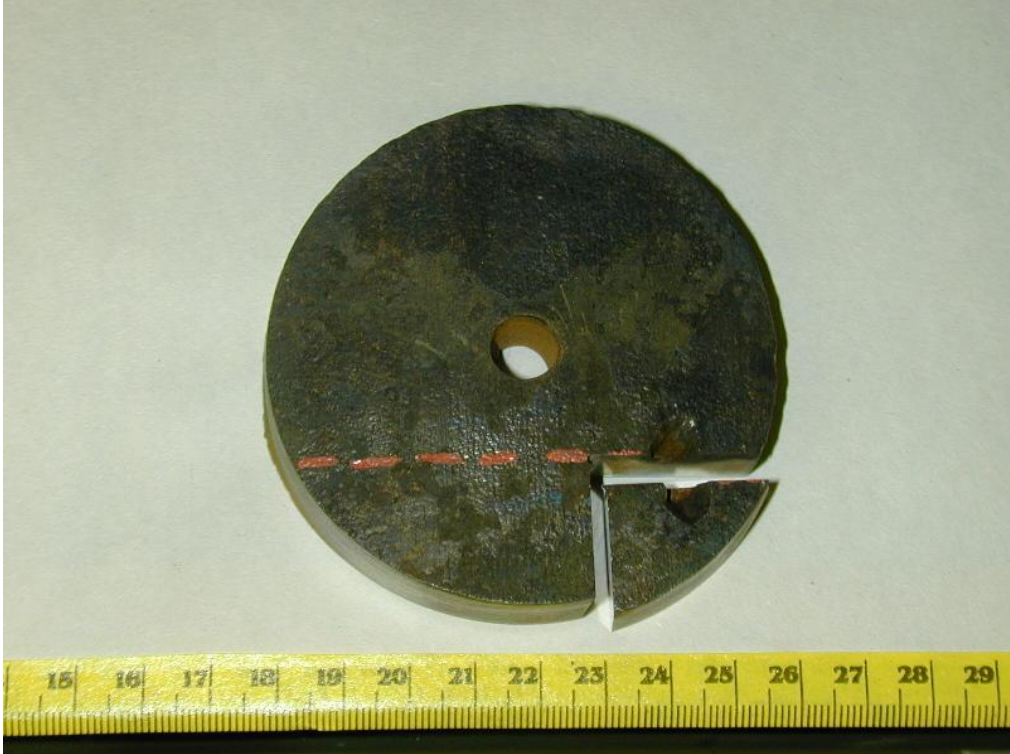
Fig. 21: Overall view of sample #3 sectioned through the pit.

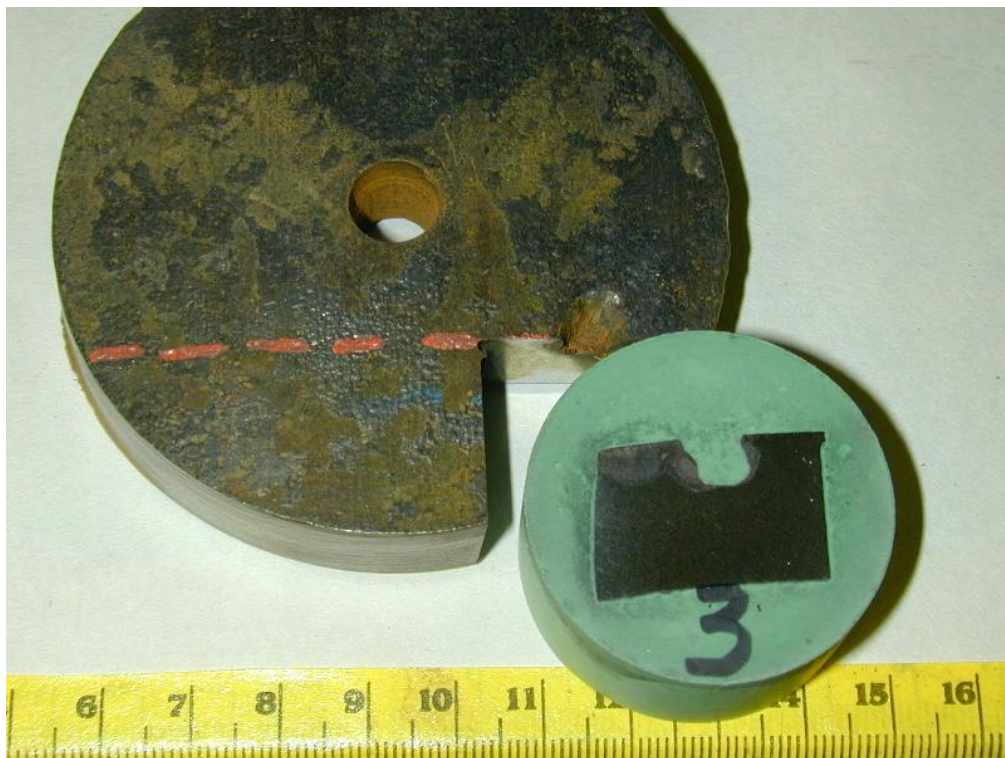
Coupon 3 had corroded with a pit to a depth of approximately 6mm (240 mils) from the exterior leaving graphite matrix (Figures 26, 31, 32, 40-44).

Fig. 26: Overall view of sample #3.
