PILOT PROJECT REPORT

Regional Infiltration and Inflow Control Program King County, Washington

October 2004

Prepared for King County by
Earth Tech Team, Seattle, WA

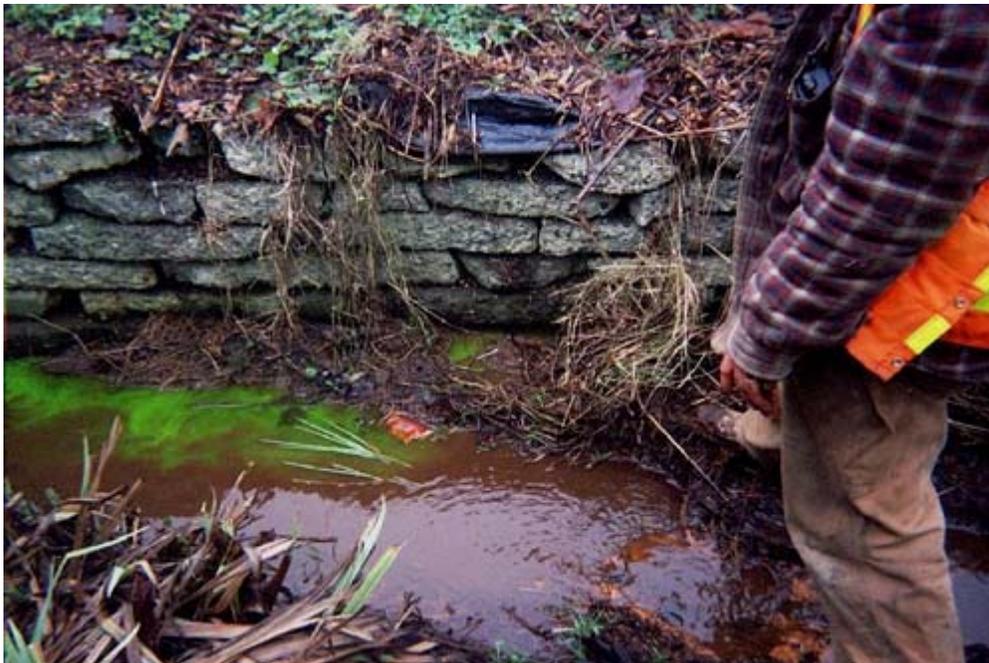
Figure 7-4. Dye Testing

Dye testing confirming down spout connected to ditch rather than sanitary sewer.

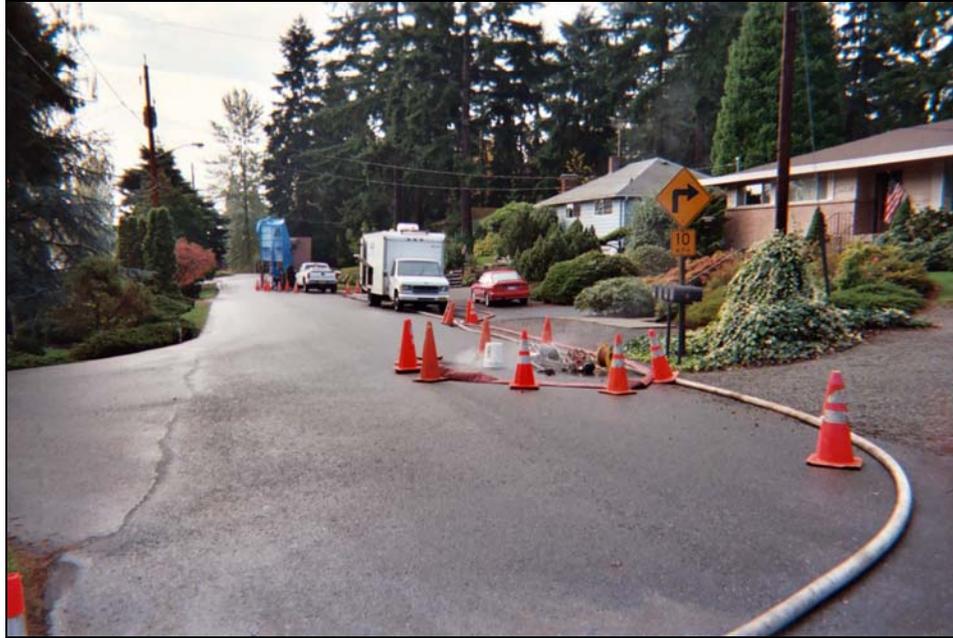
Figure 7-5. Cured-in-Place Pipe 1

Entire operation for installation of one section of sewer main CIPP.

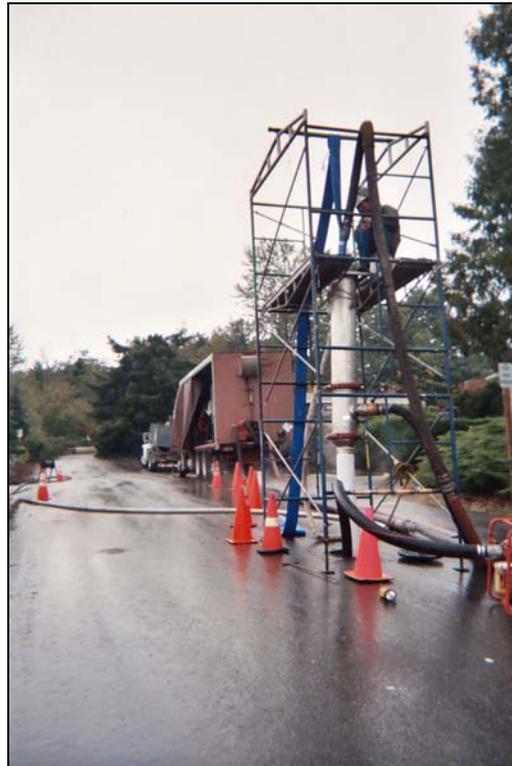
Figure 7-6. Cured-in-Place Pipe 2

Scaffolding supporting water inversion equipment for installation of CIPP in sewer main. Boiler truck is in the background.

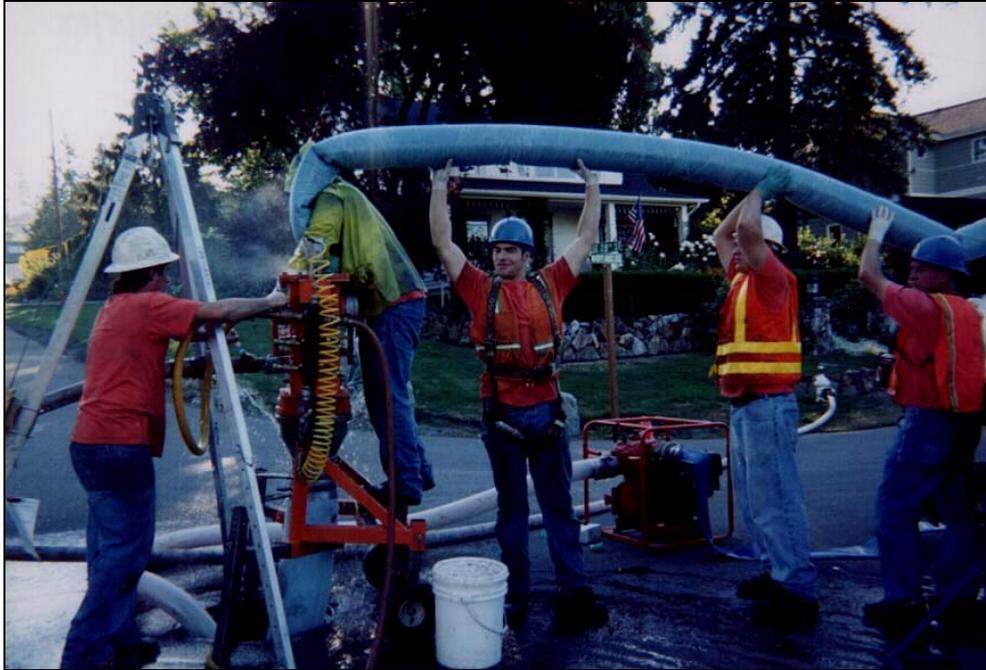
Figure 7-7. Cured-in-Place Pipe 3

Crew installing CIPP using the air inversion method.

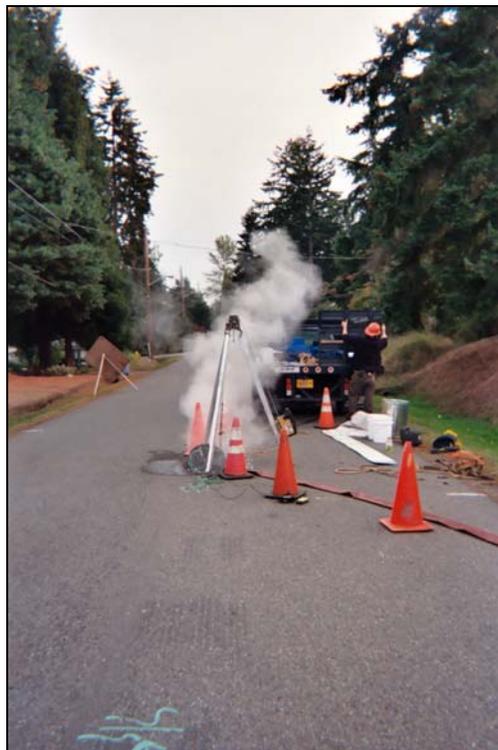
Figure 7-8. Cured-in-Place Pipe 4

Steam exiting tail end of CIPP during the curing process.

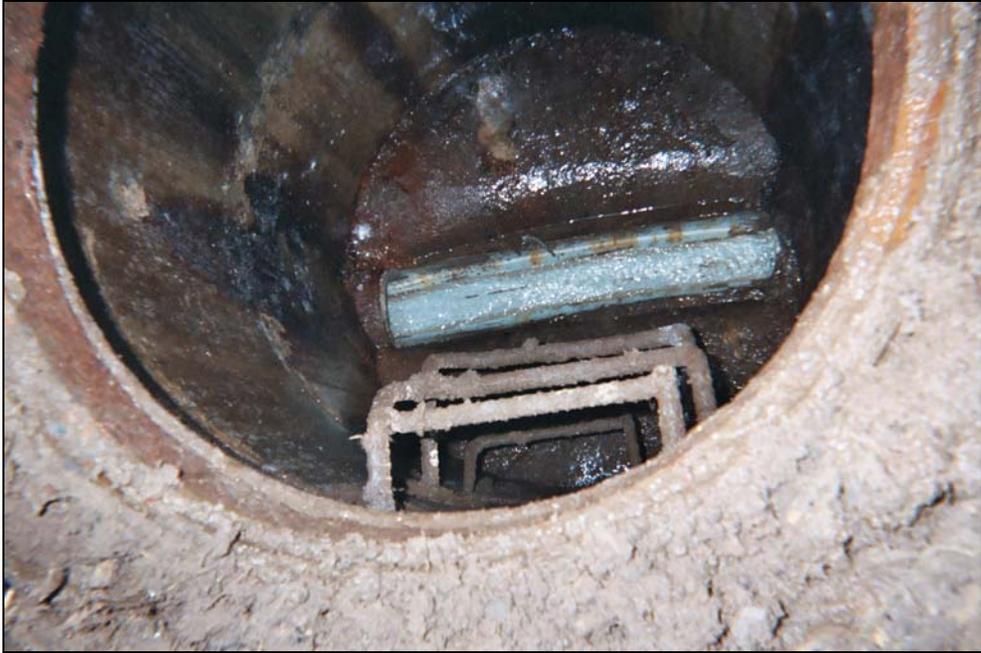
Figure 7-9. Cured-in-Place Pipe 5

CIPP in bottom of channel. Liner was installed through this manhole and the portion of the liner above the spring line of the channel was removed after curing.

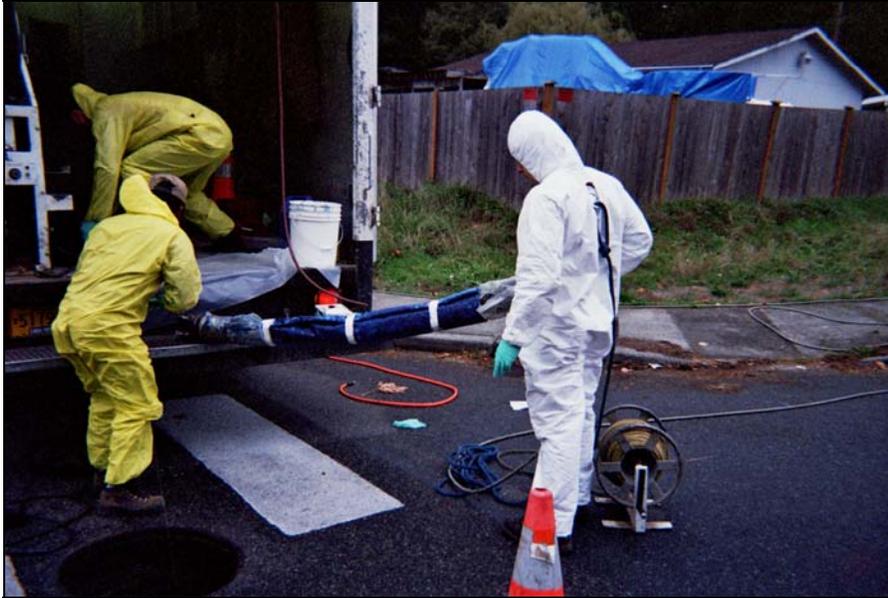
Figure 7-11. Cured-in-Place Pipe 7

A 4-foot section of blue liner wrapped around a packer in preparation for a CIPP spot repair. Blue resin is fast curing epoxy.

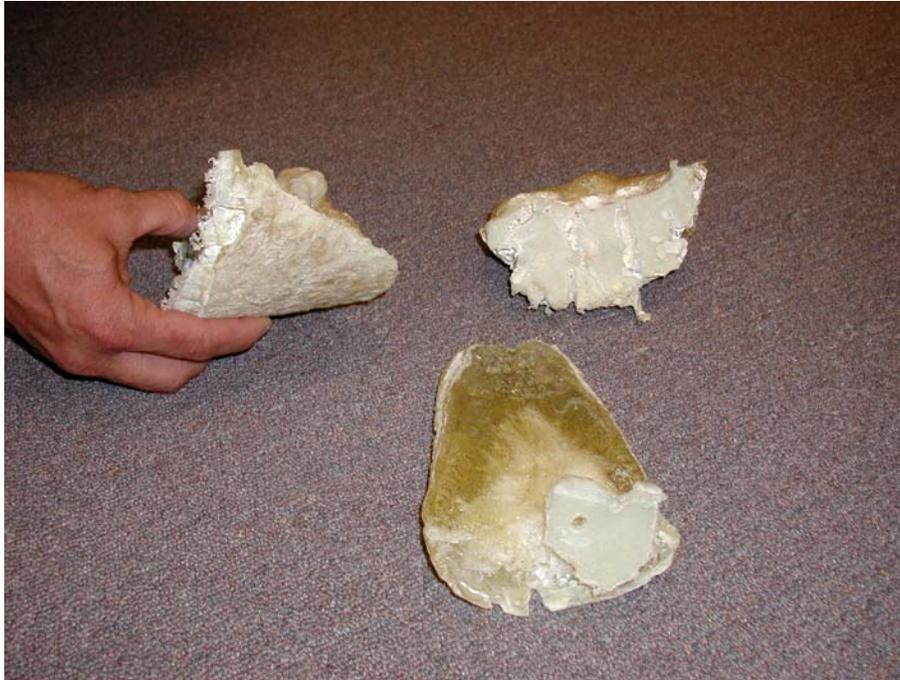
Figure 7-13. Cured-in-Place Pipe 9

Epoxy resin slugs removed from laterals.

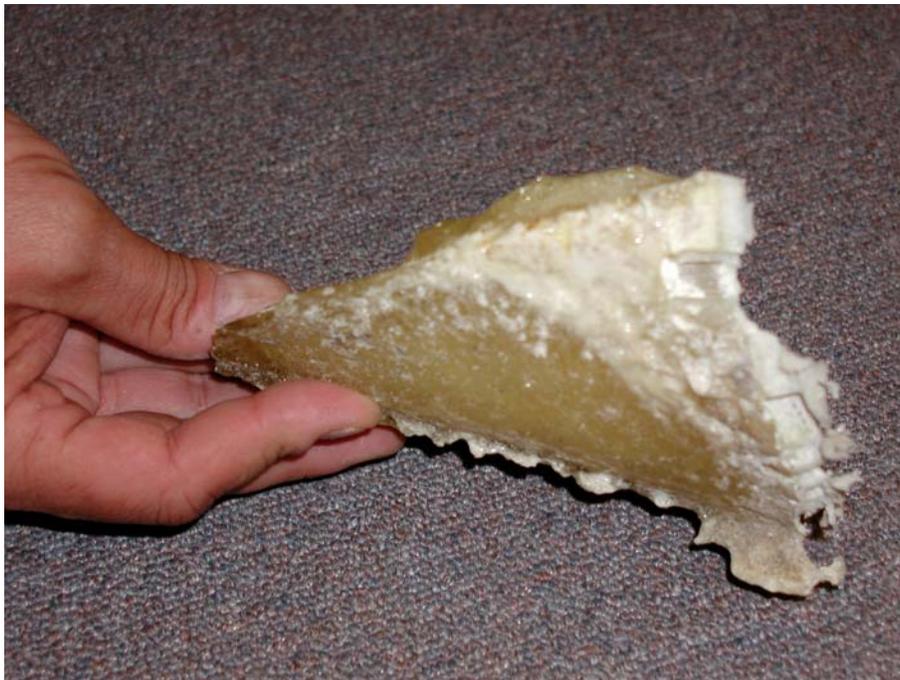
Figure 7-14. Cured-in-Place Pipe 10

Epoxy resin slug removed from laterals.

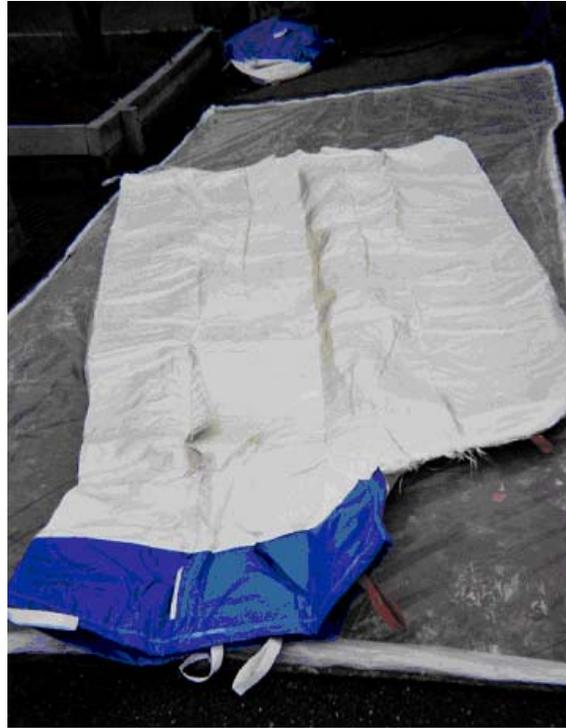
Figure 7-27. Manhole 3

Fiberglass manhole liner prior to wet-out.

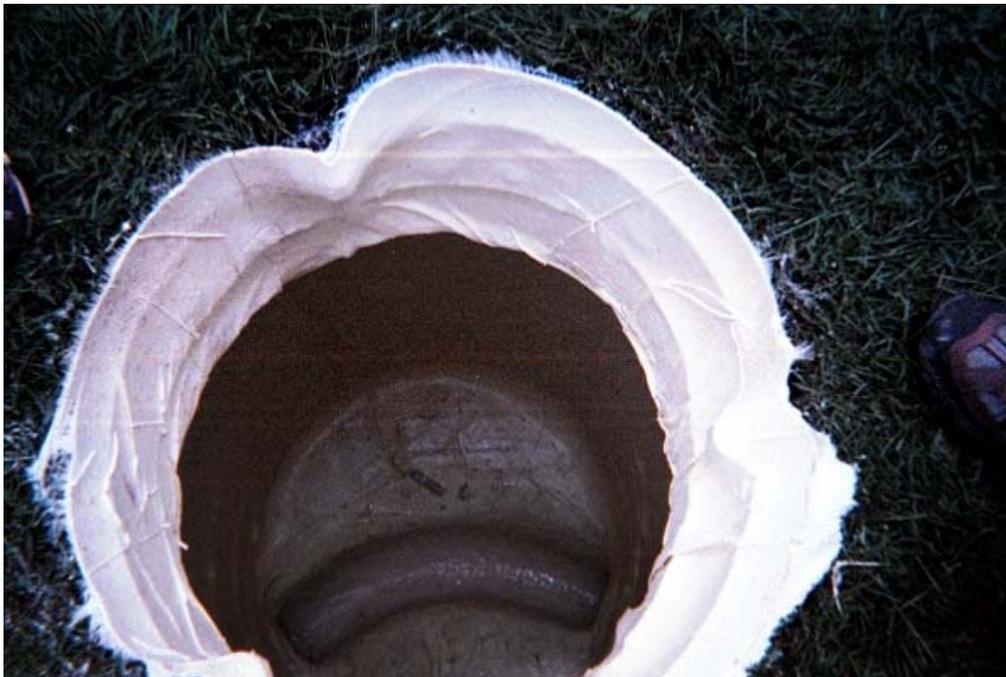
Figure 7-32. Manhole 8

Fiberglass liner before trimming.

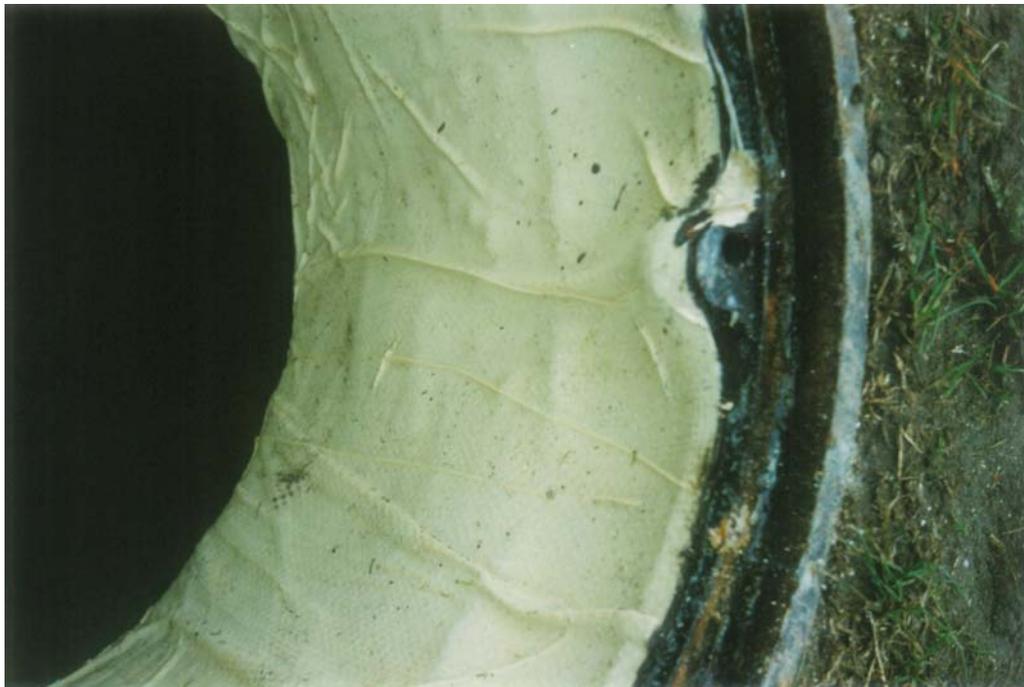
Figure 7-33. Manhole 9

Fiberglass manhole liner trimmed at the manhole ring.

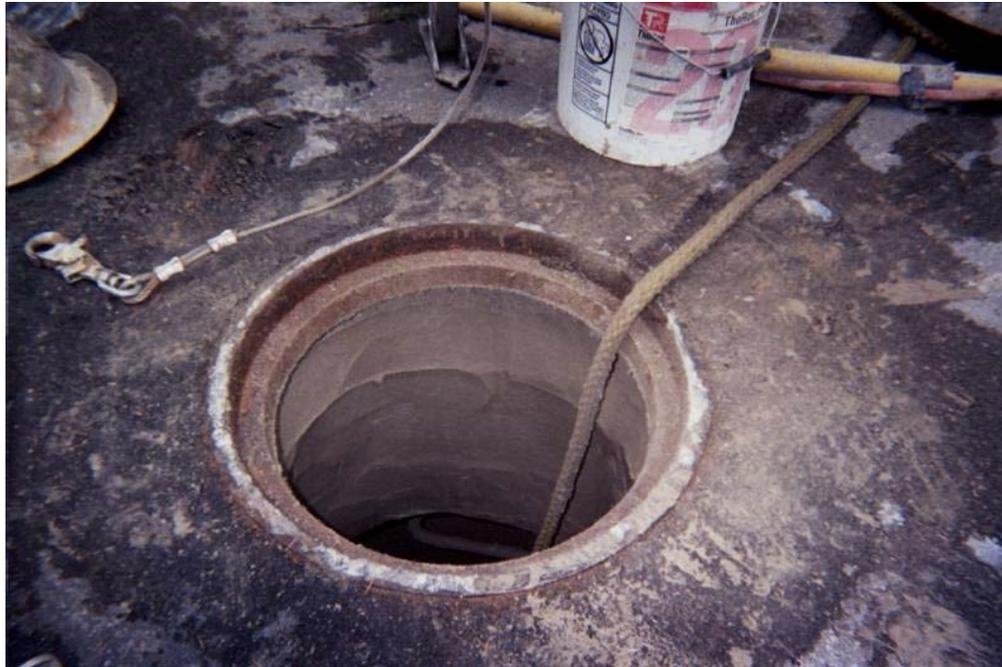
Figure 7-37. Manhole 13

Sprayed-on cementitious grout that has been smoothed with a trowel.

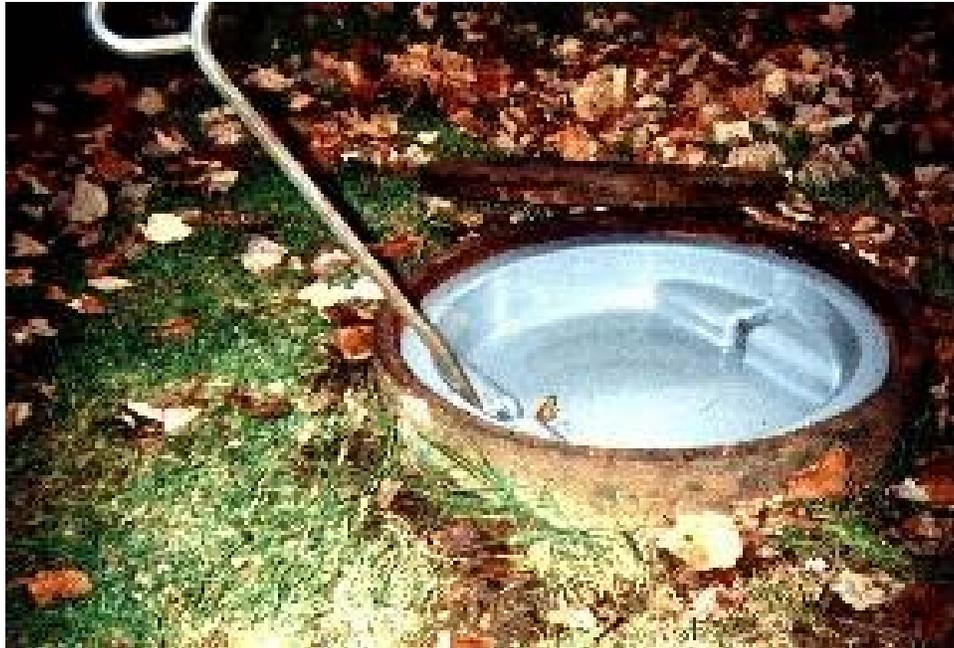
Figure 7-39. Manhole 15

Manhole pan in place. Lid will fit back in place on frame.

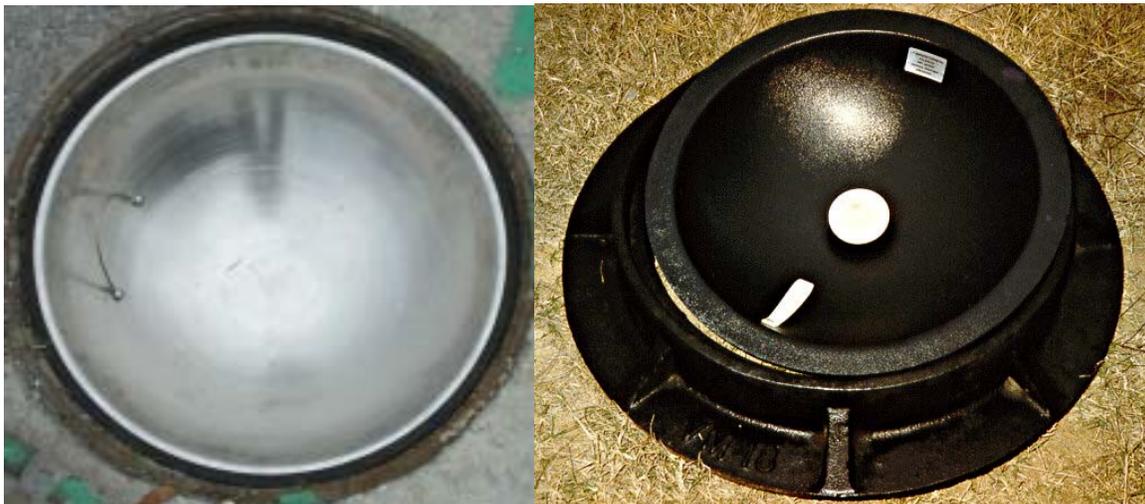
Figure 7-40. Manhole 16

Other available manhole pans. Note: pan will not allow locking lid to be installed.
